ARKLOW CASTLE:

Final Excavation Report (Licence Number: 22E0465)

CMF22-1-WI002

National Monuments reference number: WI040-029002
Anglo-Norman masonry castle

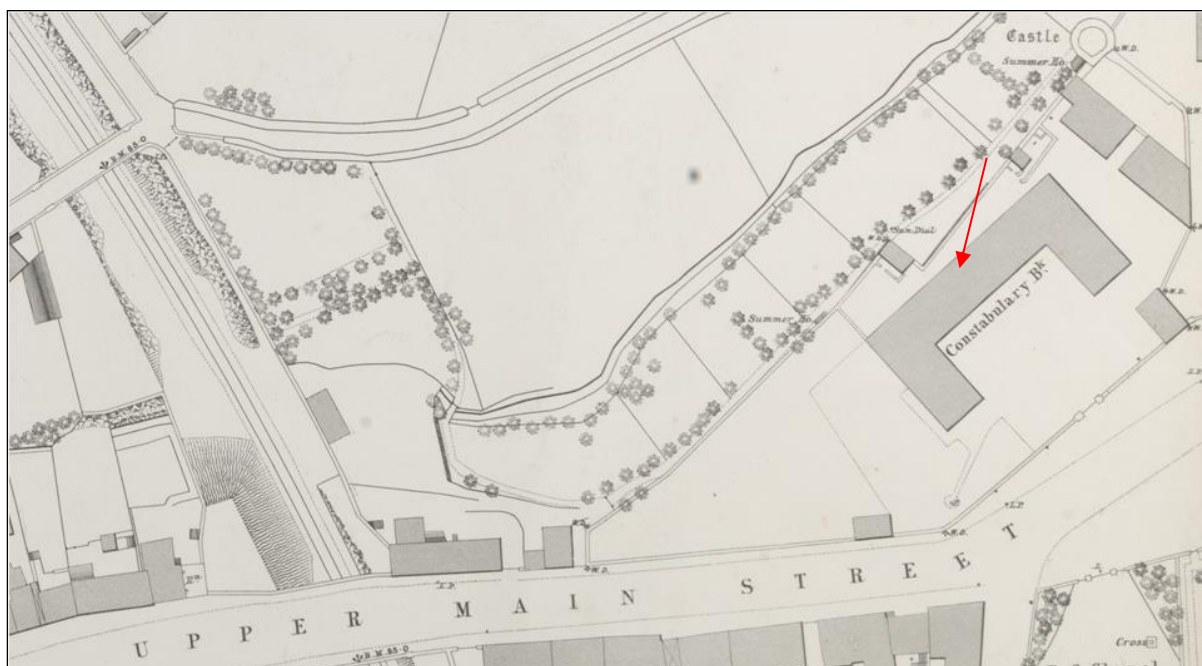
Figure 4: 1886 Map of Arklow Scale 1:500.

The 1886 map illustrates the castle and its surrounds in greater detail. The castle is depicted along with two summer houses and a sun dial along the northern boundary of the curtain wall. At the location of the sun dial (red arrow) is a rectangular building which is still extant today. Several buildings are noted within the grounds of the barracks including a pump (Figure 4).

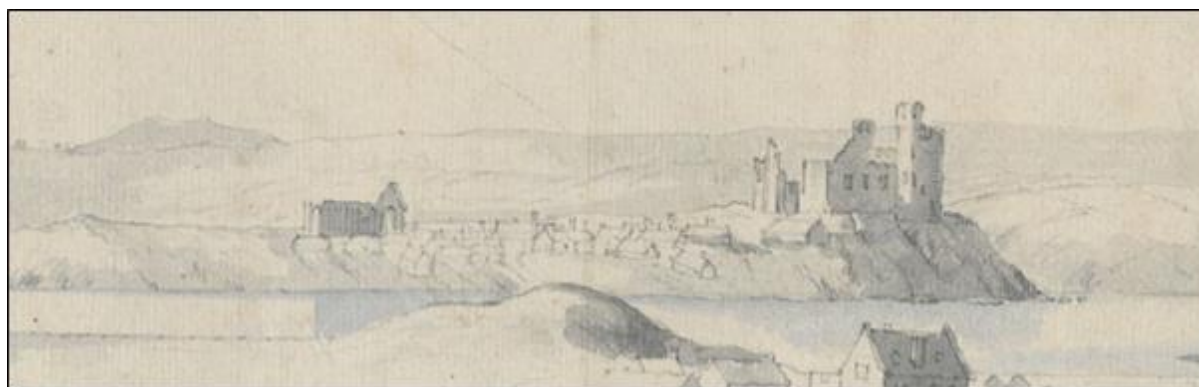
Plate 3: Prospect of Arklow in the County of Wicklow, King George III Topographical Collection c1800 (British Library).

The earliest known illustration is from circa 1800, however this may be much earlier as the barracks was built in the grounds of the castle by 1720 and it is not depicted on this illustration (Plate 3). The view is drawn facing southwest. The Avoca River is depicted along with the Dominican Abbey which is in ruins. The fact that no houses are shown east (left) of the abbey also suggests a much earlier date. The north-eastern tower of the castle is still extant. A building is depicted to the foreground adjoining the curtain wall. It may be possible that this may be the gate tower and entrance to the castle. This image is reminiscent of the gate tower entrance to Nenagh Castle depicted below.

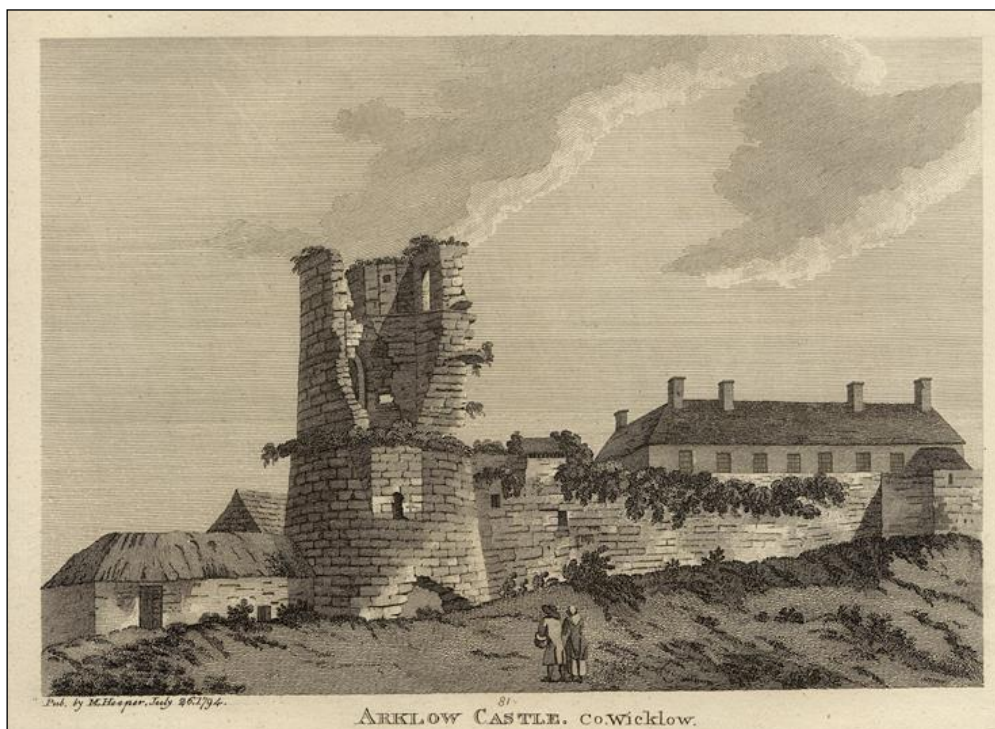
Plate 5: Arklow Castle 1794 by Francis Grose.

The above illustration depicts Arklow Castle in 1794 and is facing southwest (Plate 5). It is interesting in that the possible garderobe/machicolation is depicted along with the ground, first floor and remains of the second floor. Two openings which may indicate windows are depicted in the northern curtain wall. A square structure is visible also along with the barracks. The buildings which adjoined the curtain wall visible in plates 6 and 8 are no longer extant however a small house is depicted adjoining the tower.

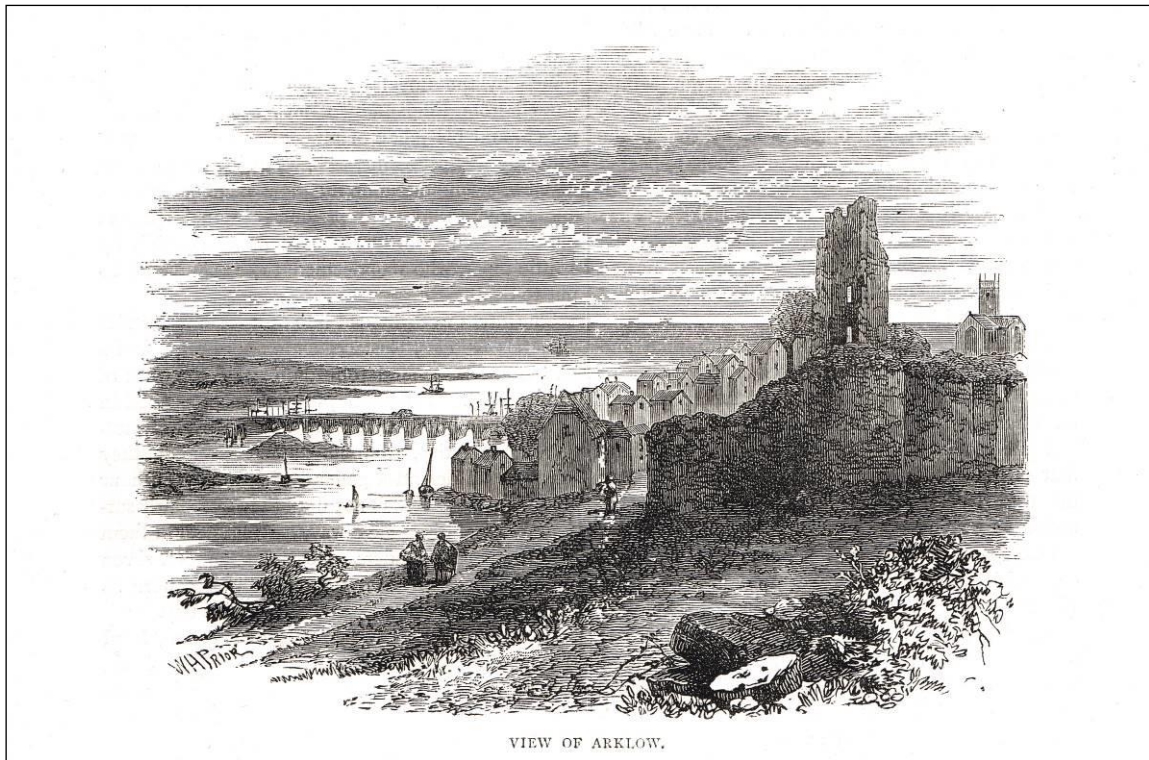
Plate 7: Original illustration from *British Battles on Land and Sea* by Cassell, Petter, Galpin & Company circa 1880.

The above illustration circa 1880 presents a different view to the previous illustrations in that it faces northeast (Plate 7). The remains of two towers are visible along with the northeast corner tower which is still extant. The parish church of Saint Mary's is also depicted.

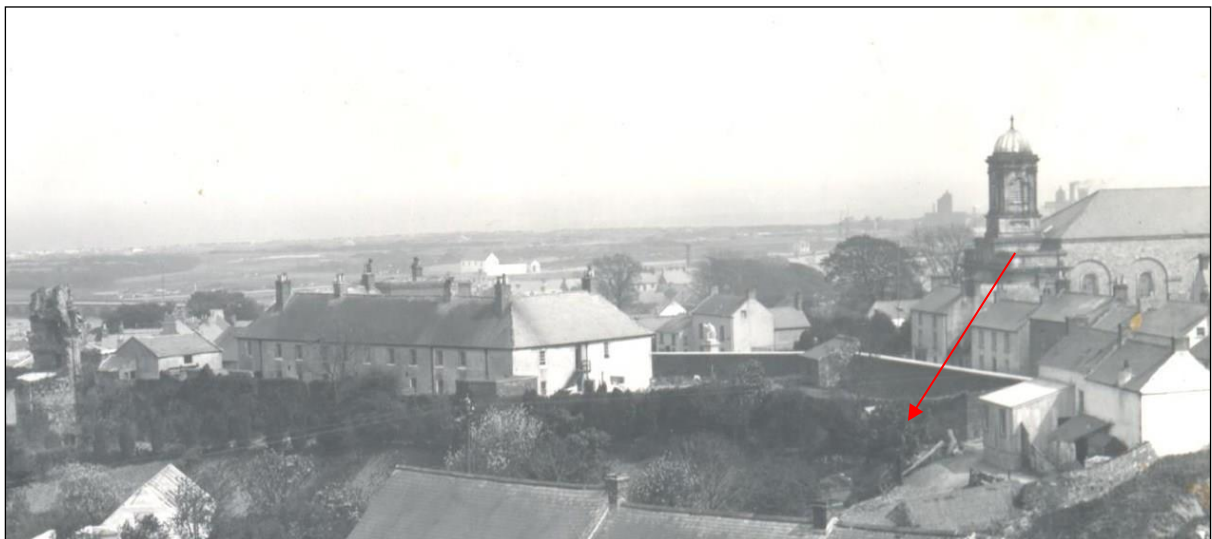
Plate 8: 1899 taken from newly completed St Saviour's church.

The above photo depicts the barracks in the grounds of the castle along with the north-eastern tower (Plate 8). The barracks was built in about 1720 and was in use by British military, Arklow Yeomanry and from the 1830's by the R.I.C until its destruction in 1922.

It is notable that the walls at the entrance to the barracks have clearly been rebuilt they are straight and without vegetation. A rectangular structure whose function is unclear is located along the length of this newly constructed wall and whether it predates the wall or is contemporary is unclear. The red arrow illustrates a curve in the wall, and it may be the remains of the original curtain wall of the castle. This section of wall with its dense vegetation does not appear to be as newly constructed as the opposite wall which faces onto Parade Ground.

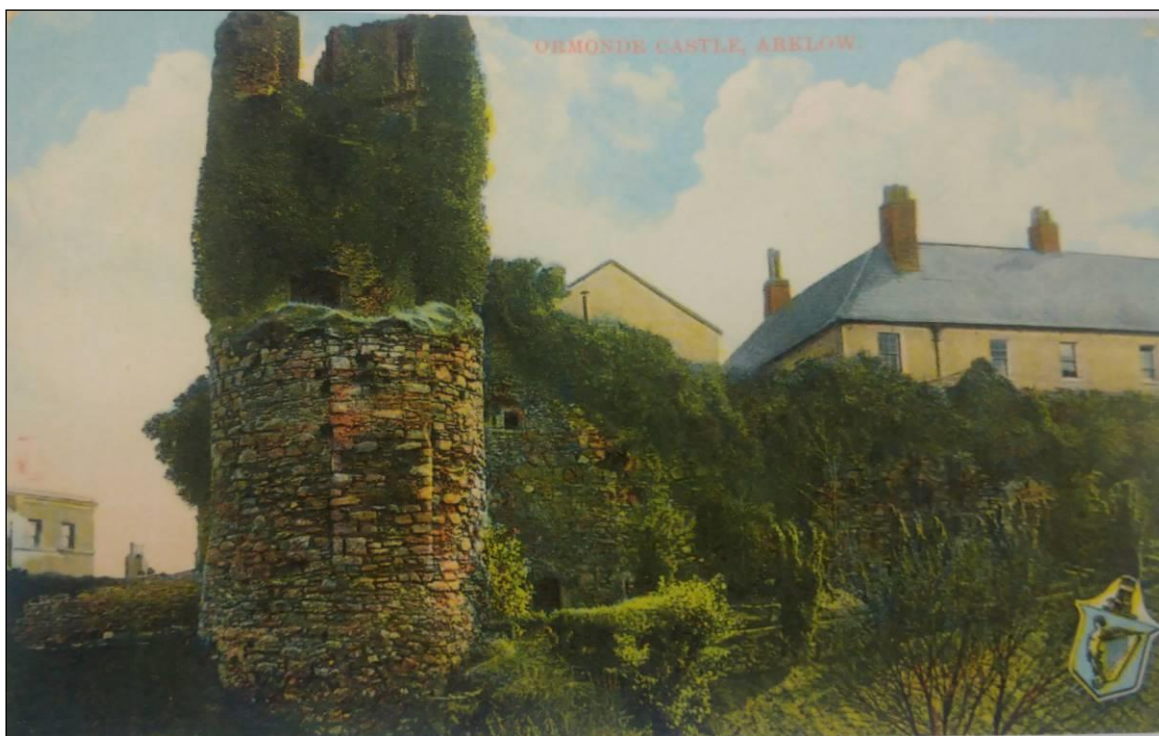
Plate 9: Ormond Castle, Arklow, Co Wicklow, Ireland postcard from the Milton series old photograph 1909.

The above photo depicts the fourth story of the tower which is no longer extant (Plate 9). A possible garderobe/machicolation is clearly visible built onto the north facing tower wall, only fragments of this structure survive today. A sallyport, window and possible arrow slit are visible to the west of the tower which is covered in ivy today. The barracks is visible in the grounds of the castle.

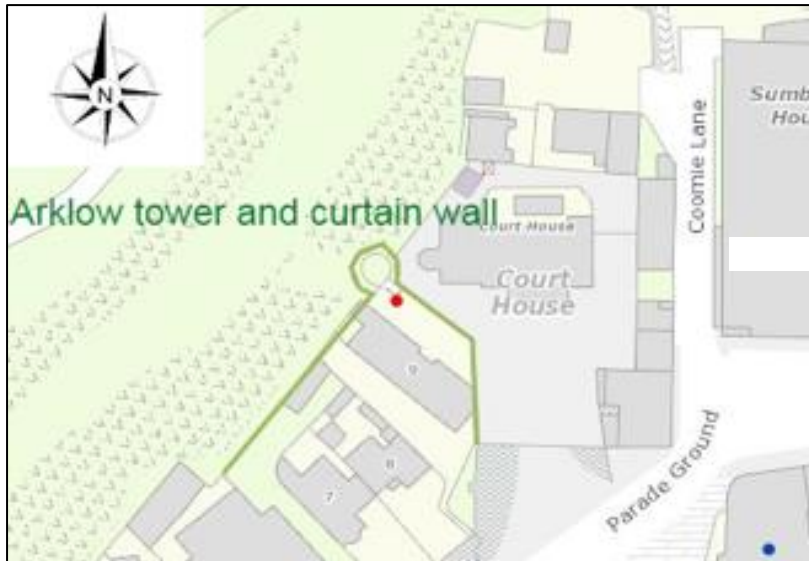
Figure 6: Arklow tower and curtain wall.

The main length of curtain wall that survives is the northeastern elevation which is curved (L c. 32m; H 4-8m) and a circular corner tower (external diameter c 5m, H 7.46m) Its construction comprises randomly coursed sandstone. This circular tower would have defended the north facing section of the castle. The curtain wall which runs northeast to southwest from the tower has a sallyport gateway and a small window which although not visible today due to the vegetation is depicted on historic photos and illustrations. This tower and the north-east-to-south-west facing curtain wall overlook what was once a stream which bounded the castle to the north and may have been used for defensive purposes acting as a wet moat.

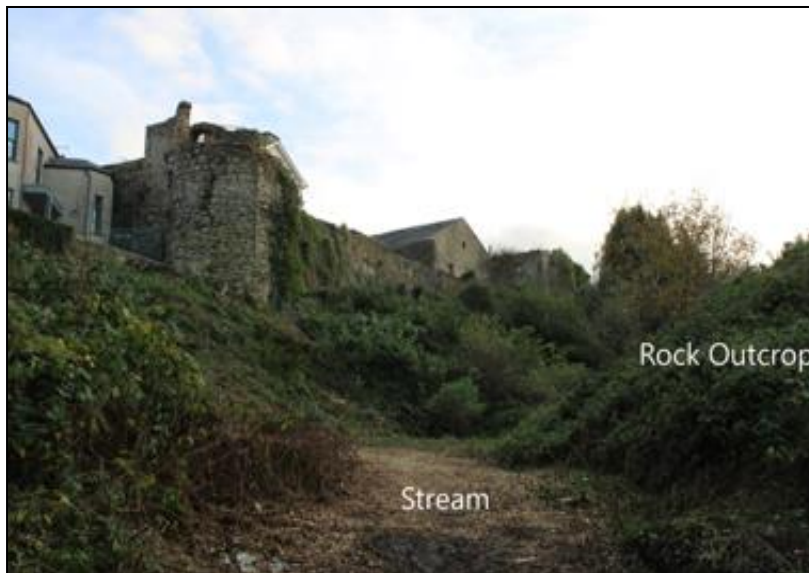
Plate 16: View of castle tower and location of old stream bed and rock outcrop facing southwest.

The ground level at this location is 10m below the castle tower. Based on the existing contours of the ground, the stream may have been up to 8m in width. It is now a culverted trickle which still flows into the Avoca River adjacent to the castle (Plate 16).

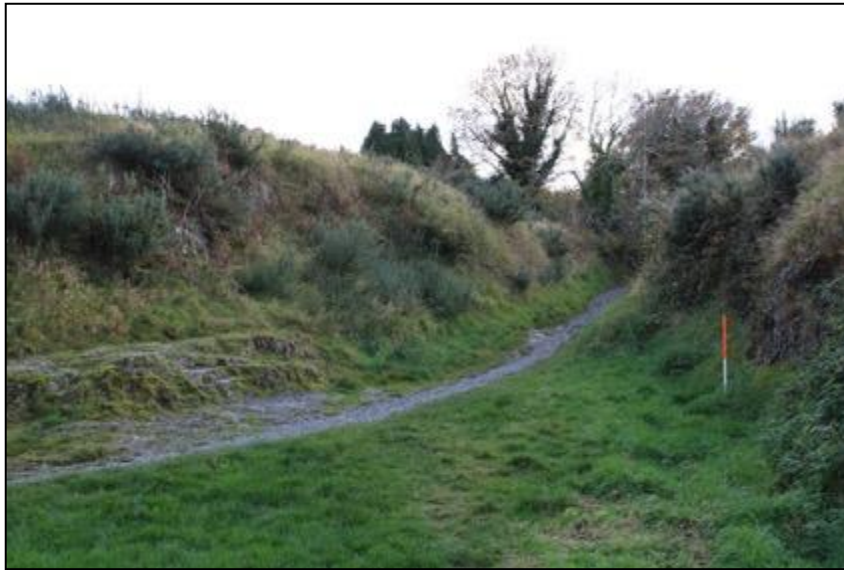
The natural terrain to the northwest of the castle comprising steep outcrops of slate bedrock may have acted as natural defensive banks and ditches. These bedrock outcrops are up to 2m in height and Coomie Lane has been cut through a section this bedrock at the Avoca River (Plate 17). The bedrock is comprised of highly fractured slate of the Ordovician Kilmacrea Formation and the underlying bedrock is visible beneath the curtain wall (ARUP, 2019).

Plate 17: Coomie Lane cut through bedrock outcrops either side of laneway.

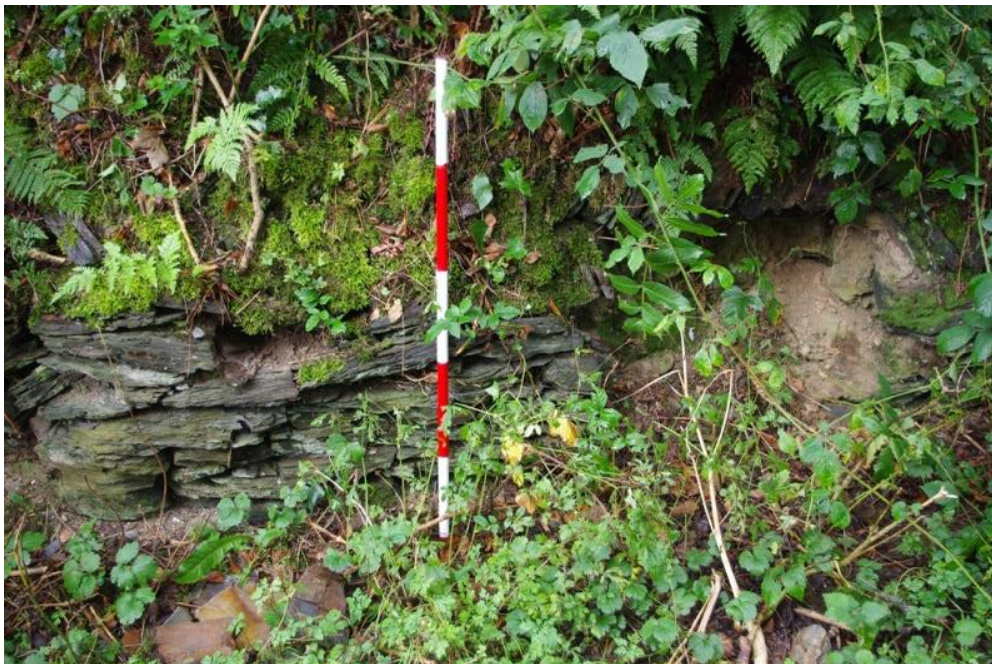
Plate 18: Detail showing extracted bedrock used to construct a drystone wall at the side of the rock-cut ditch west of the castle. It is likely that this feature is contemporary with the construction of the castle (photo: Ivor Kenny).

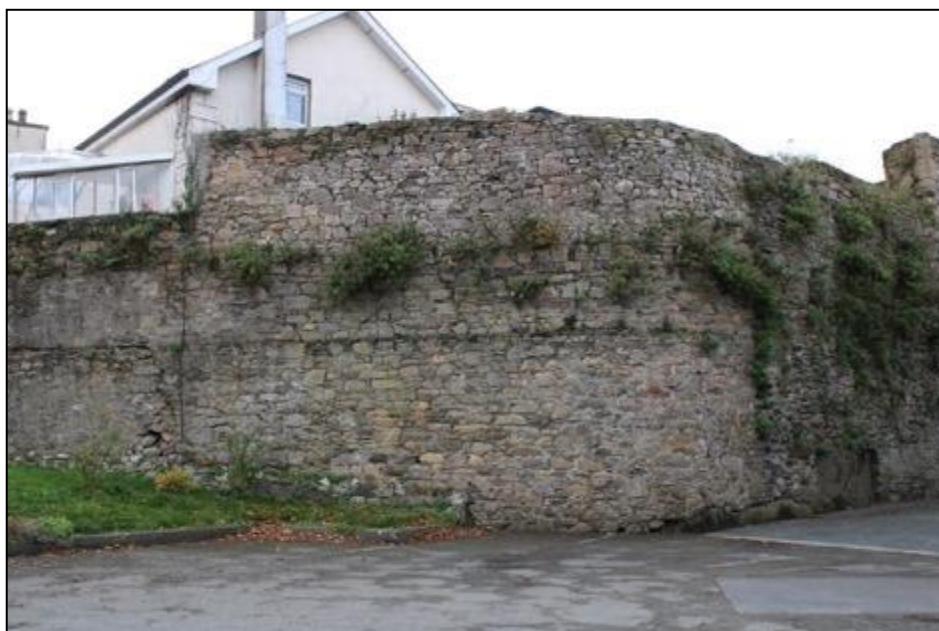
Plate 19: Eastern elevation of curtain wall photo taken facing northwest.

The eastern section of curtain wall increases in height from 3.9m at its southeastern end to 5.45m at the northern end adjacent to the tower (Plates 19 and 20). The tower has a surviving height of 7.46m. The wall is constructed with randomly coursed rubble which has evidence of cracking, loss of pointing and loose stones throughout.

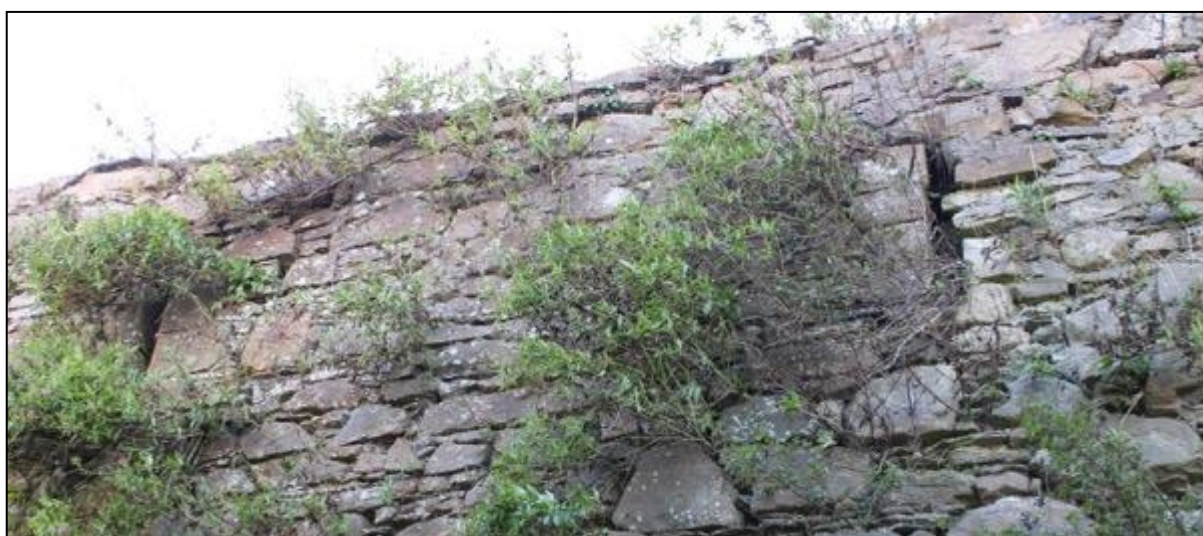
Plate 21: Arrow slits on east facing elevation- arrow slit on right of photo is adjacent to the tower.

their depth given the fact that a modern retaining wall in the grounds of Saint Annes conceals these features. These arrow slits would have been used to defend the castle. Such slits were very narrow on the outside but wider inside (splayed) to provide archers with a field of fire out of the slit while providing protection from arrows fired from outside. The arrow slit adjacent to the tower measures 0.95m in height and has an opening 0.04m in width (Plates 20-22). The second arrow slit to the south also with sandstone jambs measures 0.90m in height, has an opening of 0.10m in width (Plate 20 and 23). It appears to be splayed and has a visible depth of 0.18.

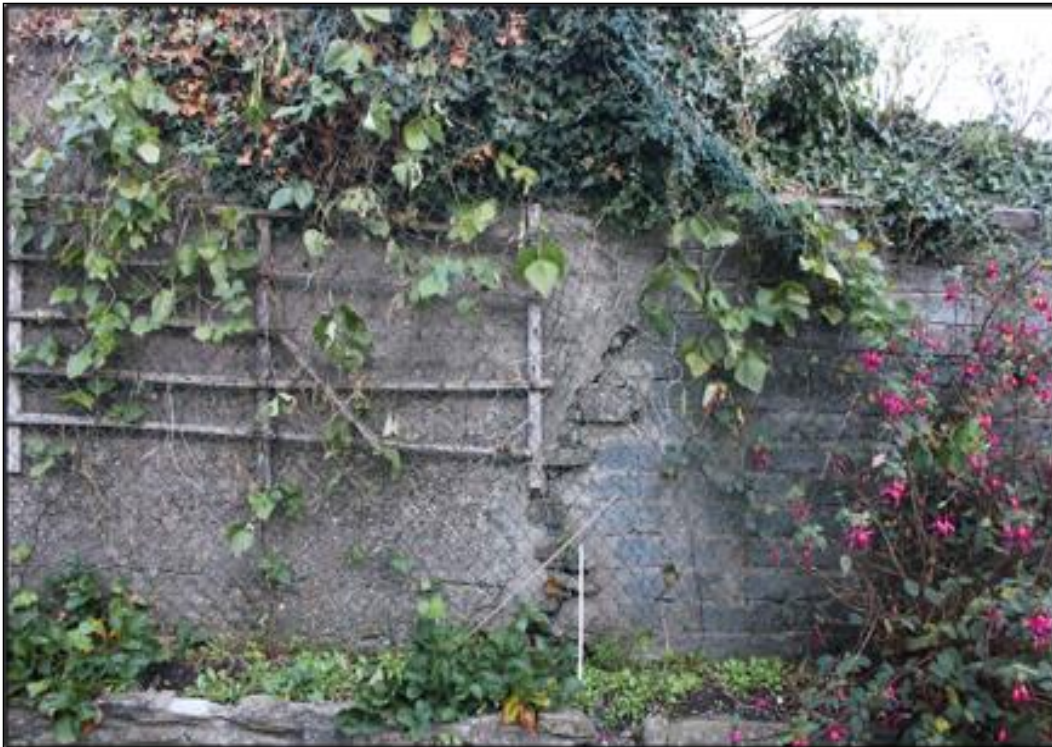
Plate 24: Modern walls built up against section of wall containing arrow slits in the grounds of St Anne's facing east, note original castle wall protruding from cement at centre of photograph.

A great deal of the rear western face of the castle wall which faces into St Anne's has been built up with modern retaining walls thus concealing the arrow slits (Plate 24).

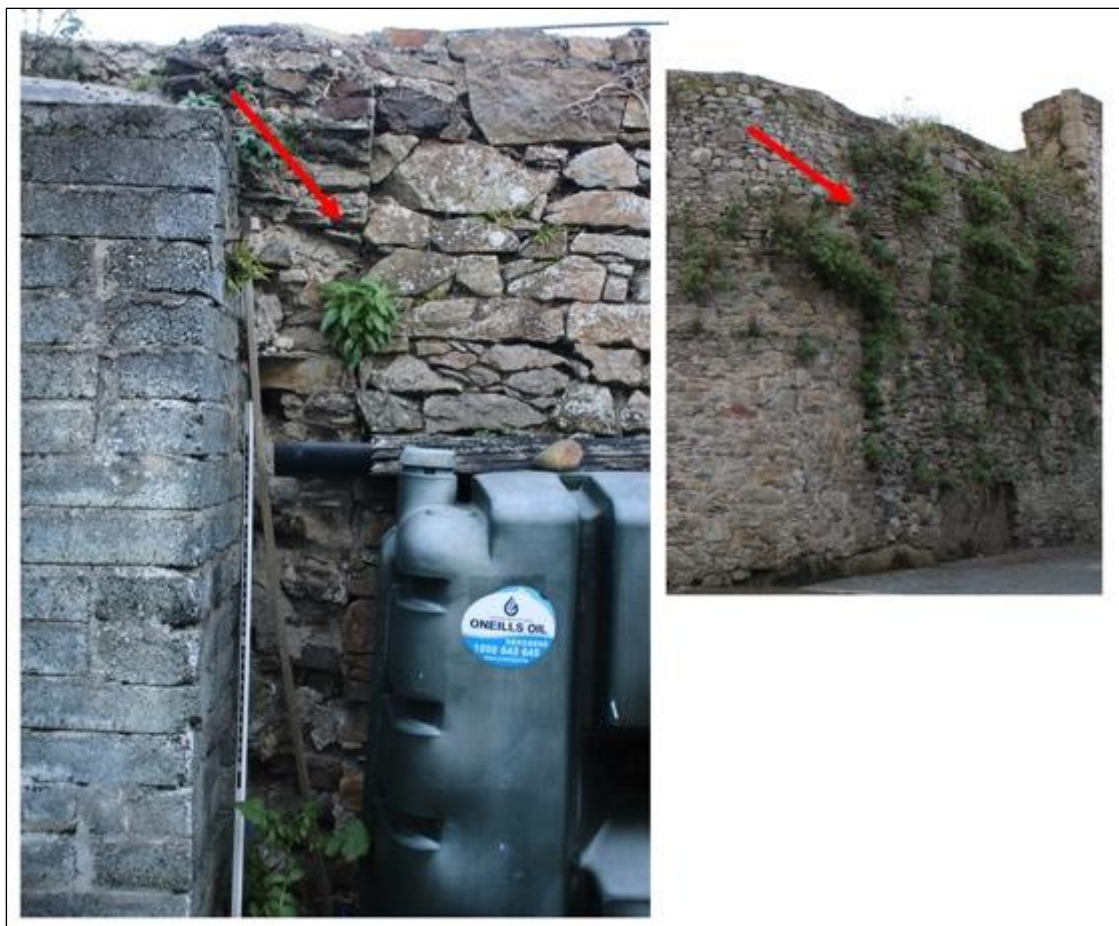
Plate 25: Left photo, west facing section of wall which appears to run west and note the abutting curtain wall to right. Right photo, northeast facing section of wall note bulge in masonry at this point.

However, a small unbuilt section survives and indicates that a wall was running west at the first floor level just south of the location of the arrow slits. This indicates that this may have been a structure/hall or building which is collapsing to the east as is evidenced by the area of disturbance and bulge in the wall at this point (Plate 25). This however may related to buildings adjacent to the 'Fuel Yard' as depicted on the Plan of the Barracks from 1869/1870 (Figure 5).

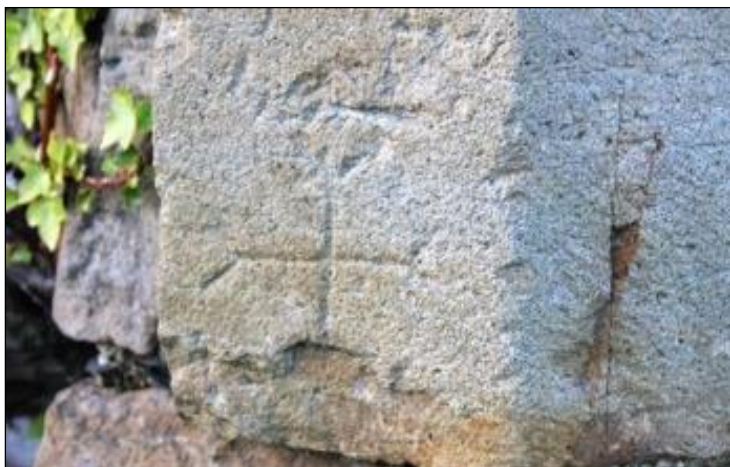
Plate 26: Masons mark at base of window.

however the mark at the bottom of the window is better executed (Plates 26-28). It is in the centre of the sandstone block which is 0.18m wide at this point.

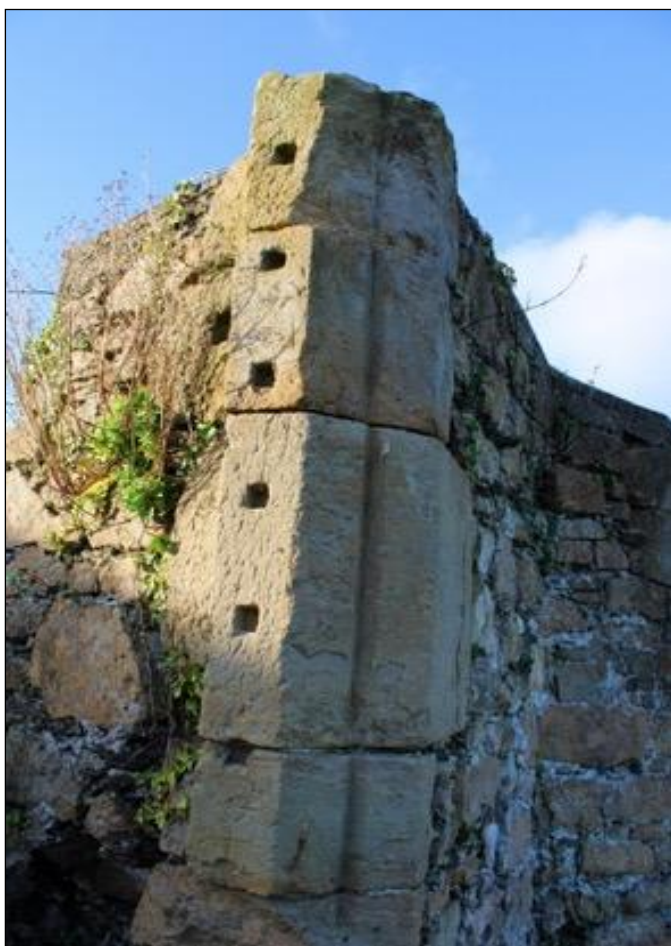
Plate 27: Sandstone window with glazing bar holes second floor.

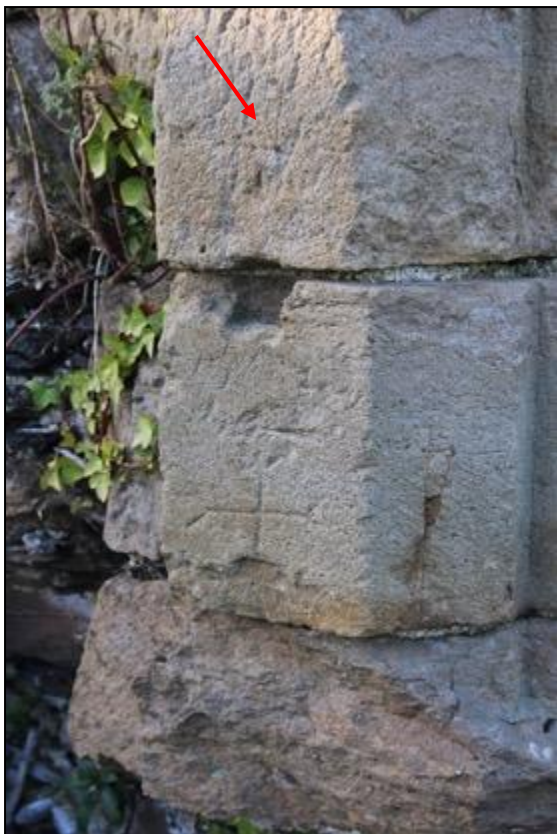
Plate 28: Masons marks, red arrow marks lightly punched mark which appears to have been replaced with more definite mark at base of the window.

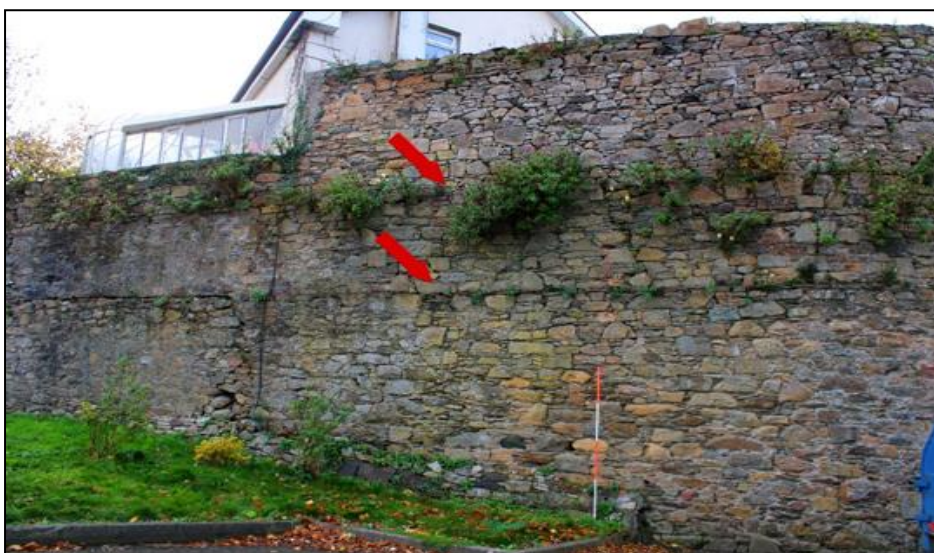
Plate 29: Curtain wall note two phases of construction. The top of the first phase is capped with flat slate stones.

The stretch of curtain wall to the south of the possible structure appears to have been built in two phases (Plate 29). A single putlog hole is visible in the curve of the wall just below the second phase of construction (Plate 30). It comprises a rectangular hole with a flat slate stone protruding from the base of the hole. In examples at Nenagh Castle this type of feature is built into the wall on stairwells to provide light. It is also possible that further examples existed further up along the curtain wall which is no longer standing. .

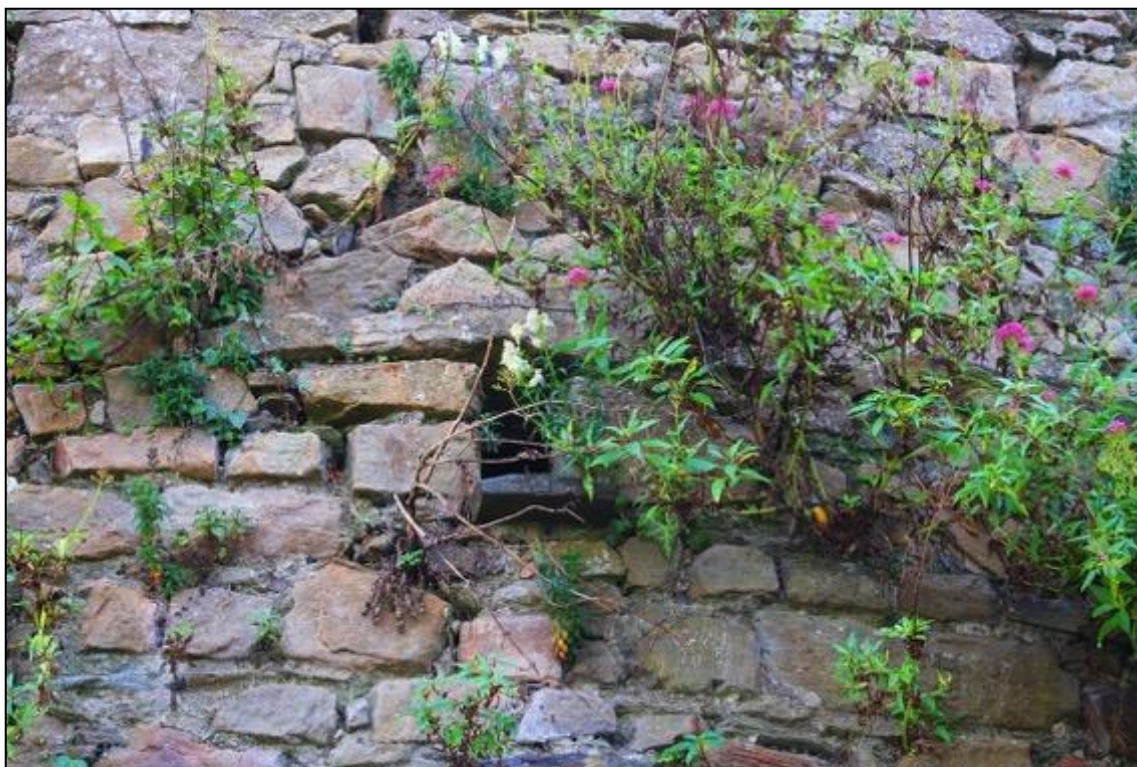
Plate 30: Putlog hole on northeastern elevation of curtain wall.

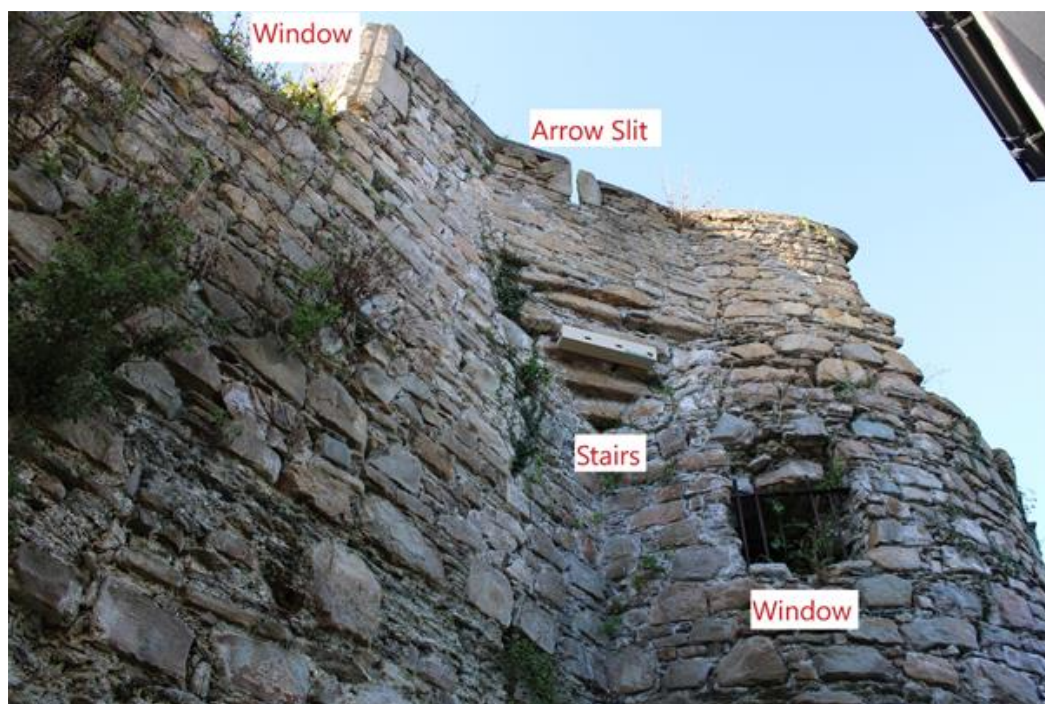
Plate 32: First and second storey of tower with arrow slit on stairs which leads to the no longer extant third storey.

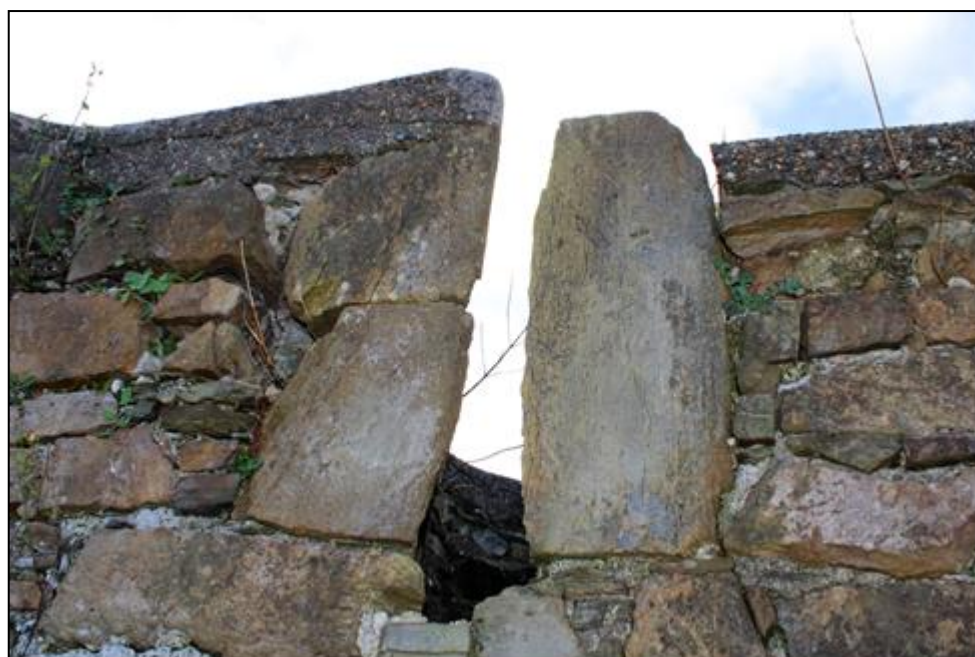
Plate 33: Sandstone splayed arrow slit in tower (see above plate 37 for location).

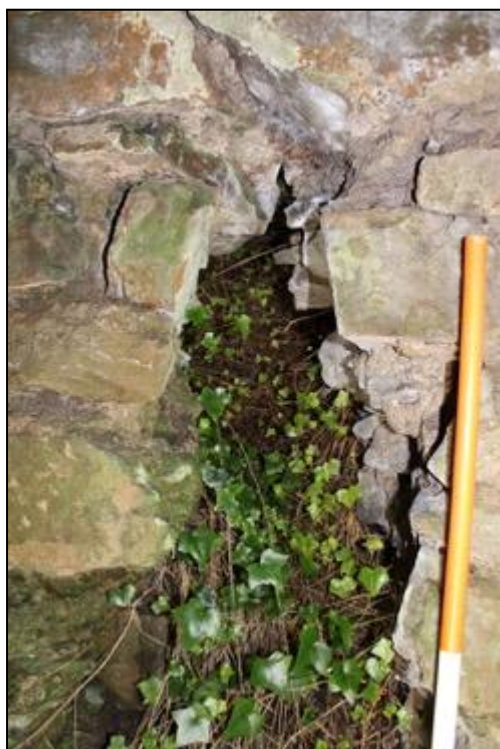
Plate 35: Collapsed section on masonry in north section of wall in tower.

A small section of the wall has collapsed in the northern wall of the tower where the machicolation is located and it was possible to record that the internal dimensions of the chute which is 1.55m wide and 0.90m deep. Two north-south running walls appear to abut the external wall of the first floor to create the aforementioned chute which would have enabled any waste to drop from the garderobe into the wet moat below. It was not possible to get an accurate height of the chute as the surface has been concreted over on the second floor of the structure. The toilets of a castle were usually built into the walls as appears to be the case at Arklow.

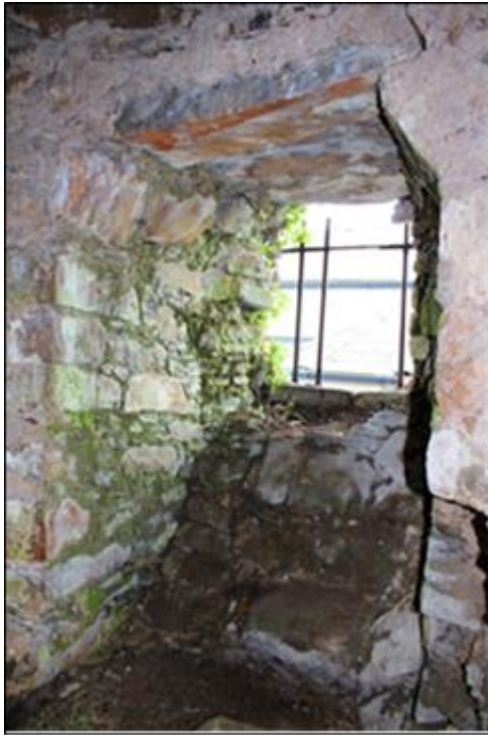
Plate 36: Embrasure in eastern face of tower.

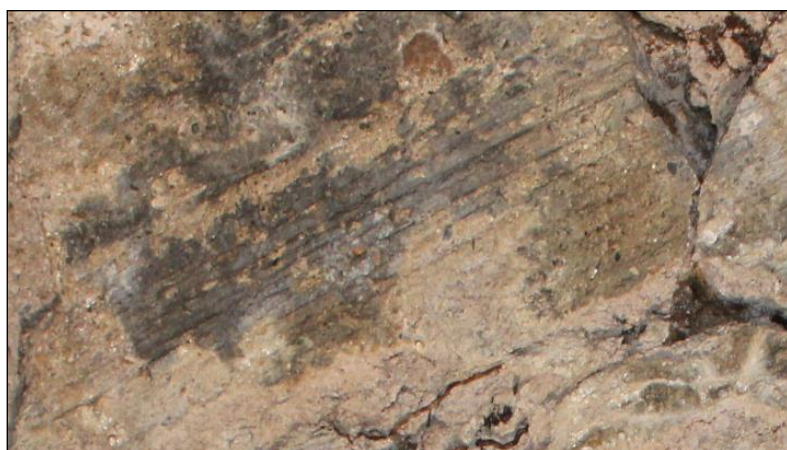
There is no evidence of wickerwork at Arklow however possible plank centring was identified in a section over the embrasure in the eastern embrasure of the tower (Plate 39). It is possible that remnants of centring may have collapsed into the room and is contained within the backfilled material within the tower. There is evidence of modern repair in the southern half of the soffit as evidenced by sand and cement which appears to have been plastered onto the roof in sections as evidenced by trowel marks (Plate 42). This work may have been carried out when the second floor was concreted over.

Plate 39: Possible plank centring note the wood grain imprints and mortar sealing the plank.

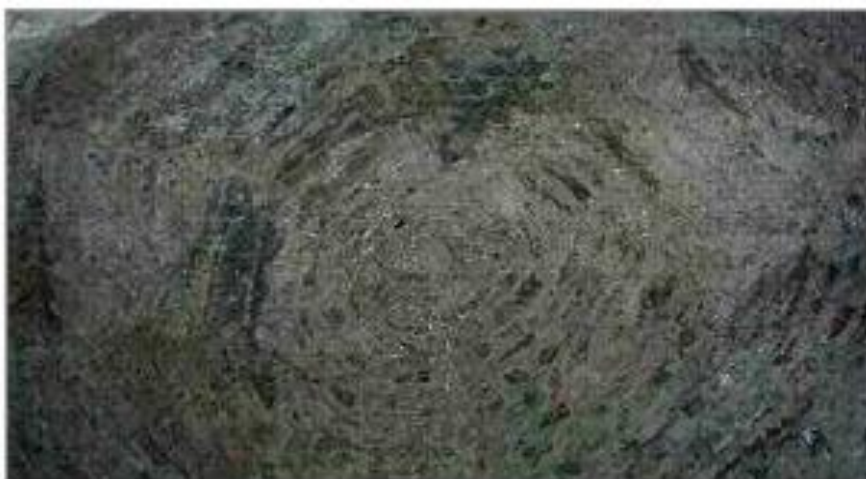
Plate 40: Extract from structural survey report illustrating soffit of 1st floor level in tower.

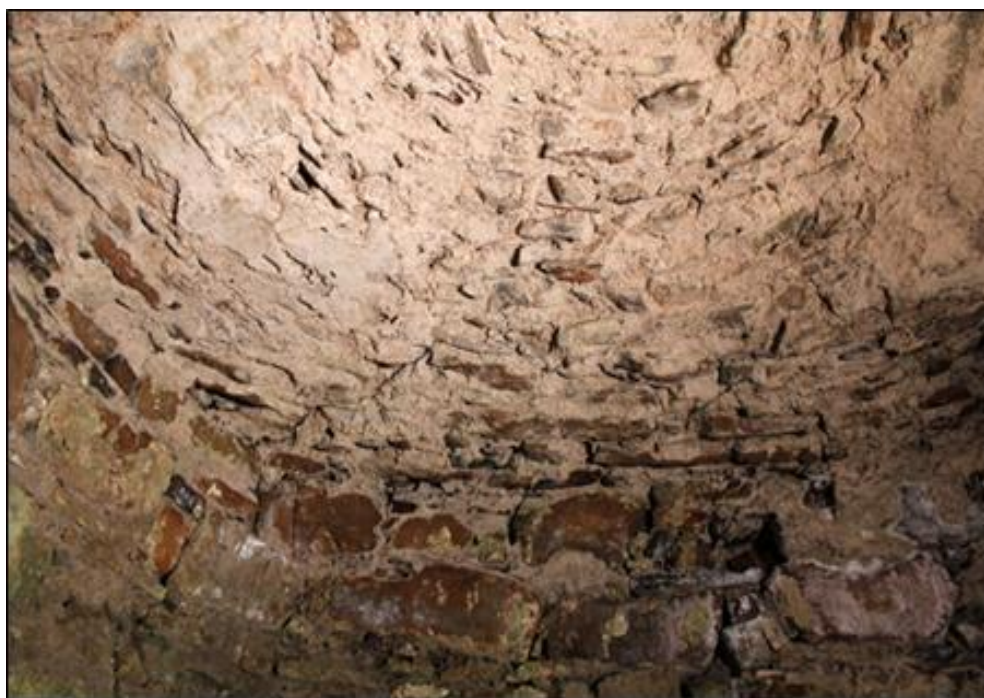
Plate 41: Northern section of soffit within tower.

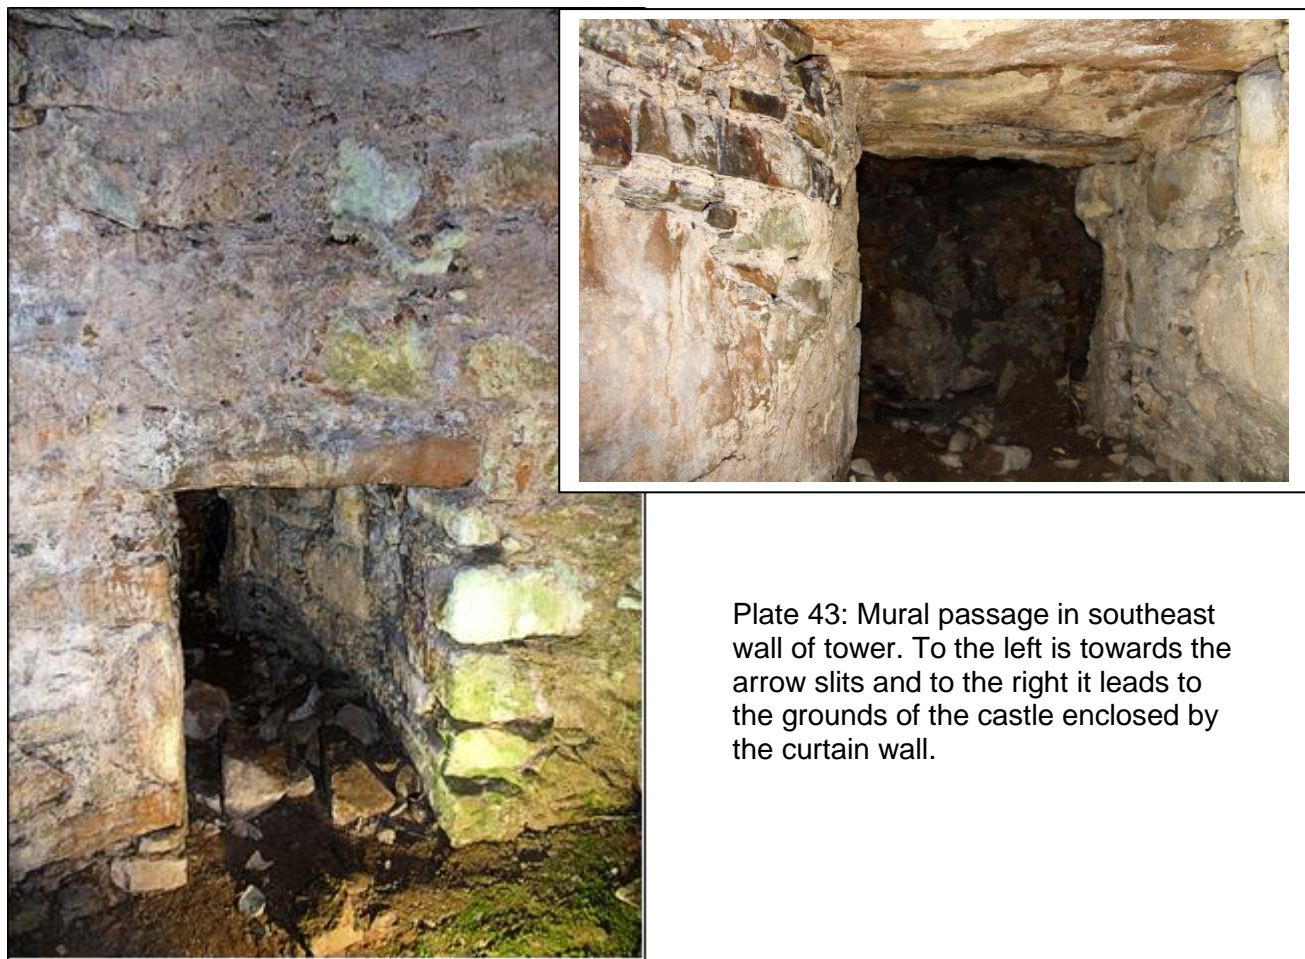
Plate 43: Mural passage in southeast wall of tower. To the left is towards the arrow slits and to the right it leads to the grounds of the castle enclosed by the curtain wall.

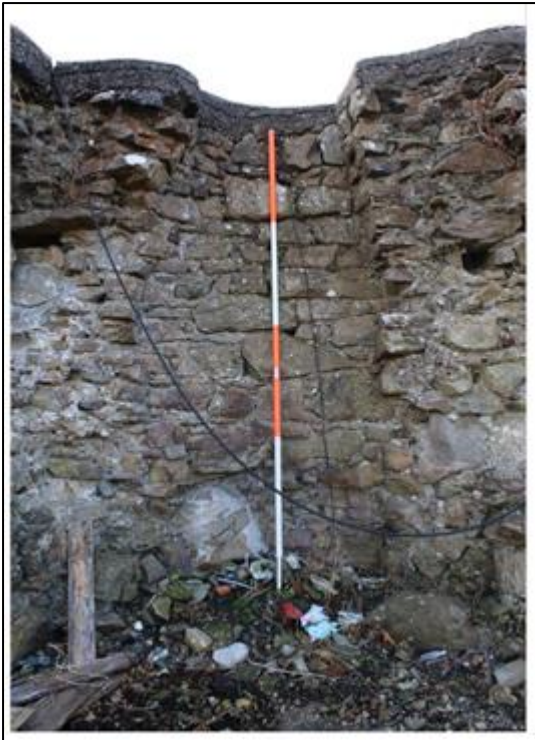
The floor on the second level of the tower has been concreted over and an iron railing is used as edge protection. It is unclear if the spiral stairs continued to the lower level. Other features noted at this second-floor level is a recess possibly a fireplace set into the southern wall of the

tower immediately west of the doorway (Plate 46). It is 2.20m in height and 1.80m wide at the base and tapers as it runs up to what would have been the third floor of the tower.

Plate 47: View of possible fireplace in southern wall of tower, facing south.

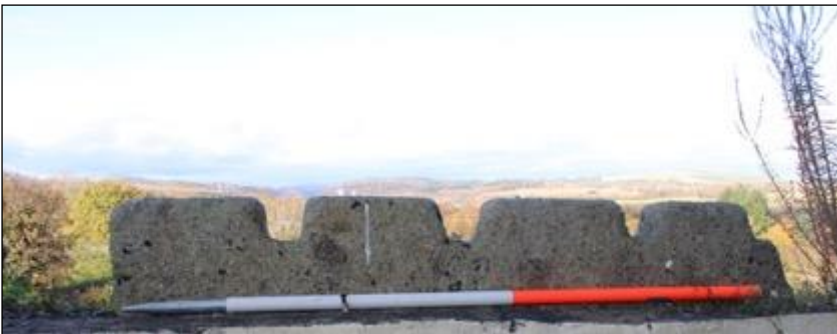
Two pieces of cut granite stone were observed in the grounds of Saint Anne's (Plate 48 and Plate 49). Their exact date and function are uncertain however, they may relate to activities at the castle. Originally the stone may have been in one piece and today survives as two pieces 0.88m and 1.30m in length. The stones have a height of 0.23m and are 0.10m in average thickness. The U-shaped indents are uniformly set 0.26m apart and the indent is cut to a depth of 0.09 and is 0.08m in width at the base of the cut.

Plate 48: Cut granite stone in grounds of St Anne's.

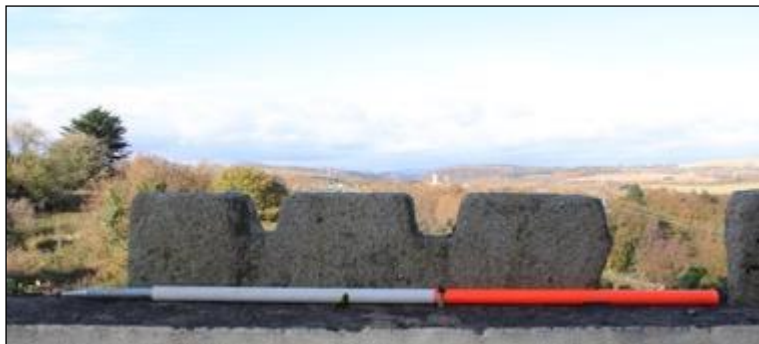
Plate 49: Cut granite stone in grounds of St Anne's.

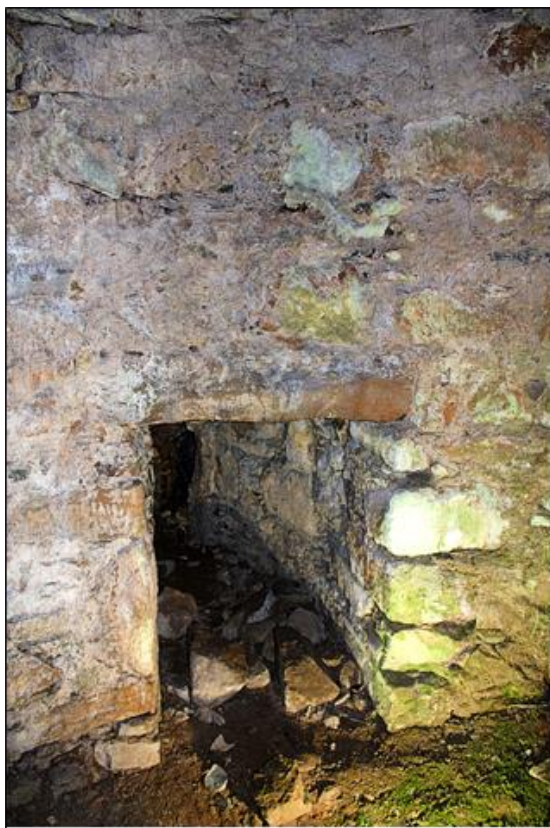
Plate 52: Mural passage in southeast wall of tower, prior to excavation.

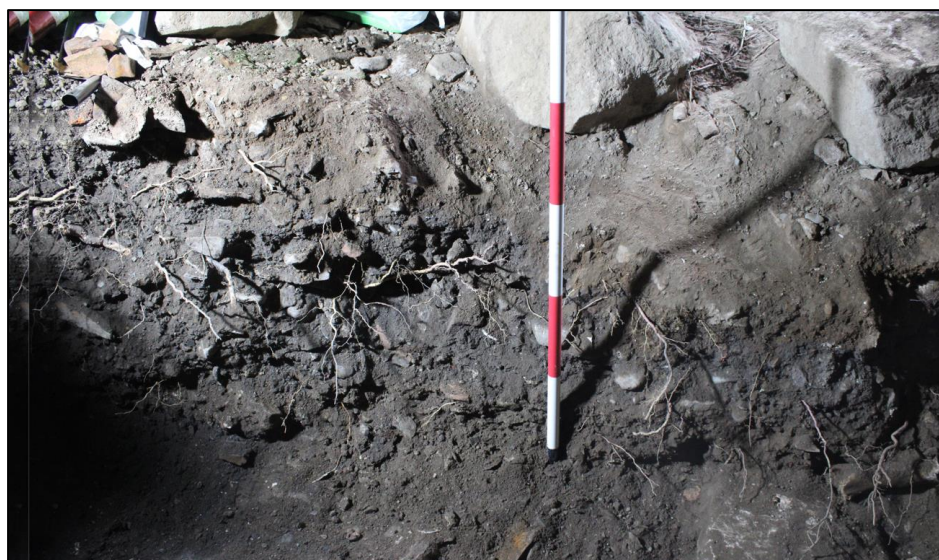
Plate 53: Southwest facing section of tower, C1, C2 and C3.
