ARKLOW CASTLE:

Final Excavation Report (Licence Number: 22E0465)

CMF22-1-WI002

National Monuments reference number: WI040-029002
Anglo-Norman masonry castle

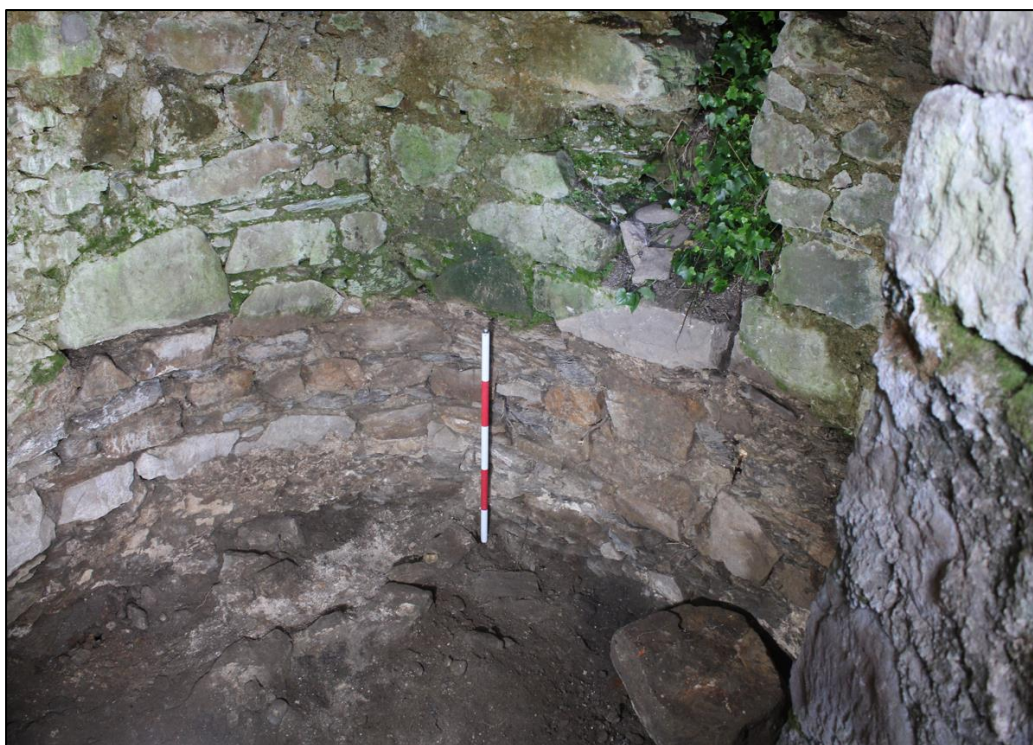
Plate 54: Floor surface C4 and C4.

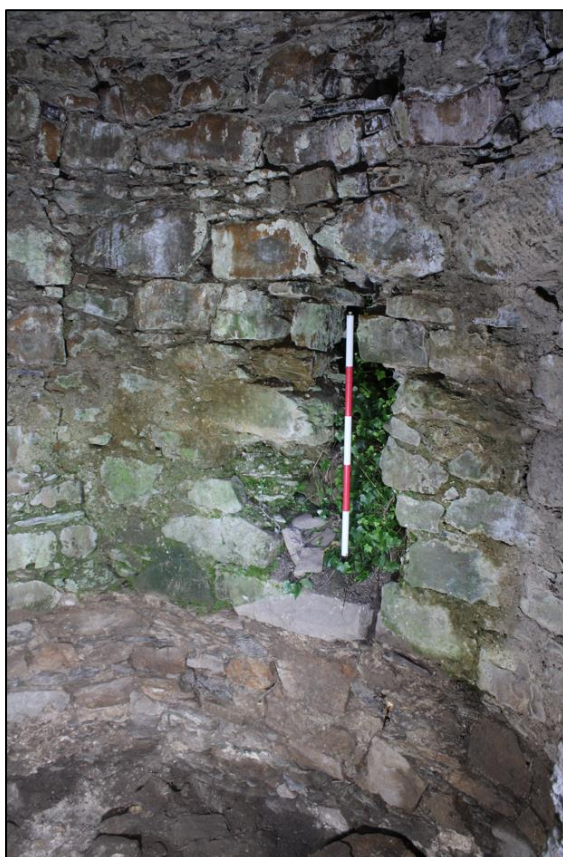
Plate 55: Crack in tower at garderobe.

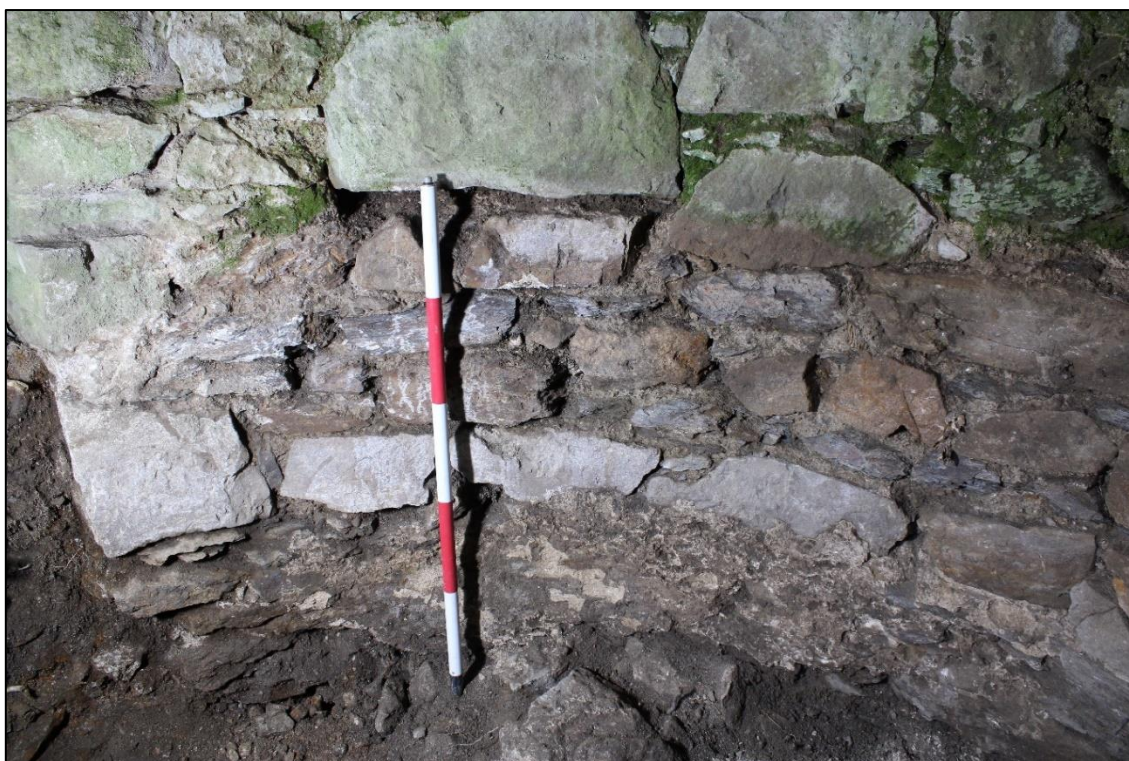
Plate 56: Mortar C5.

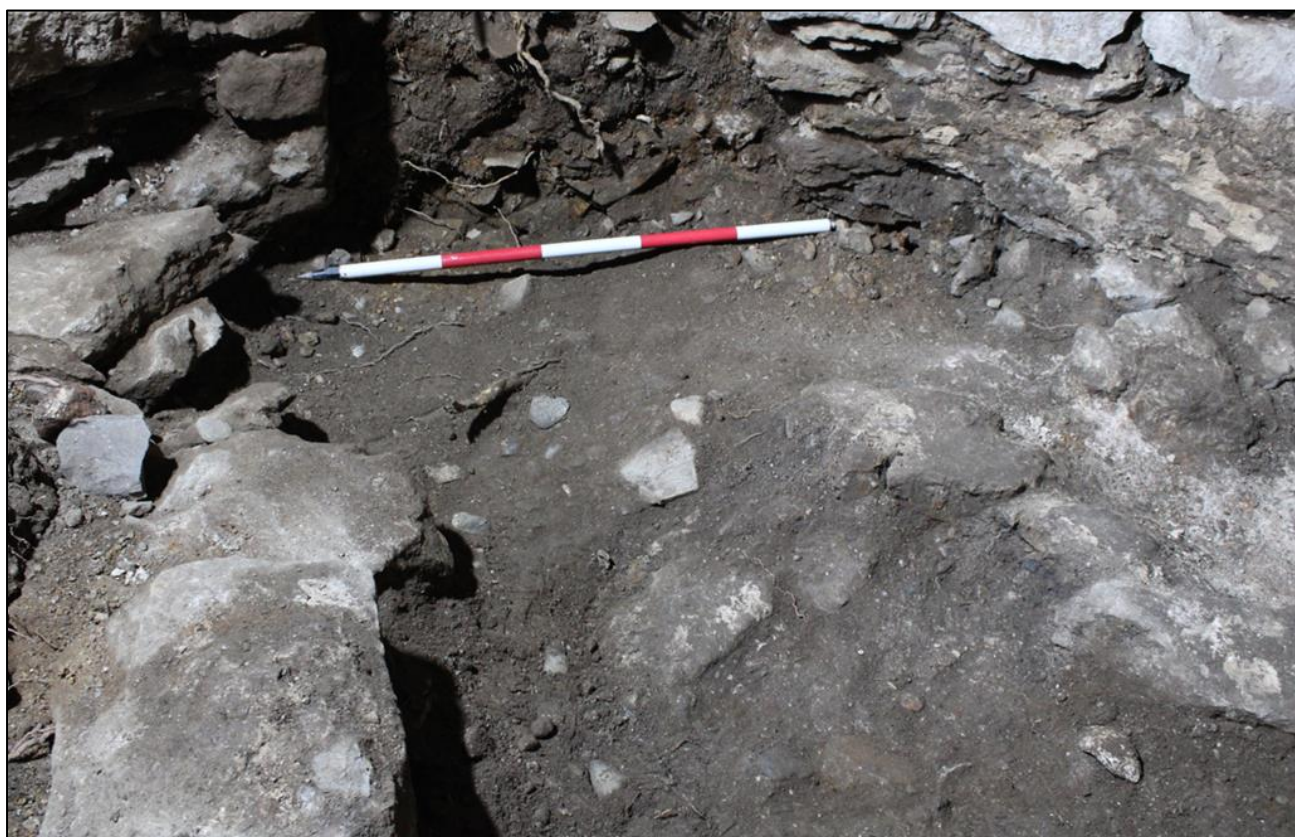
Plate 57: Possible floor surface C4 and mortar C5 at entrance passage.

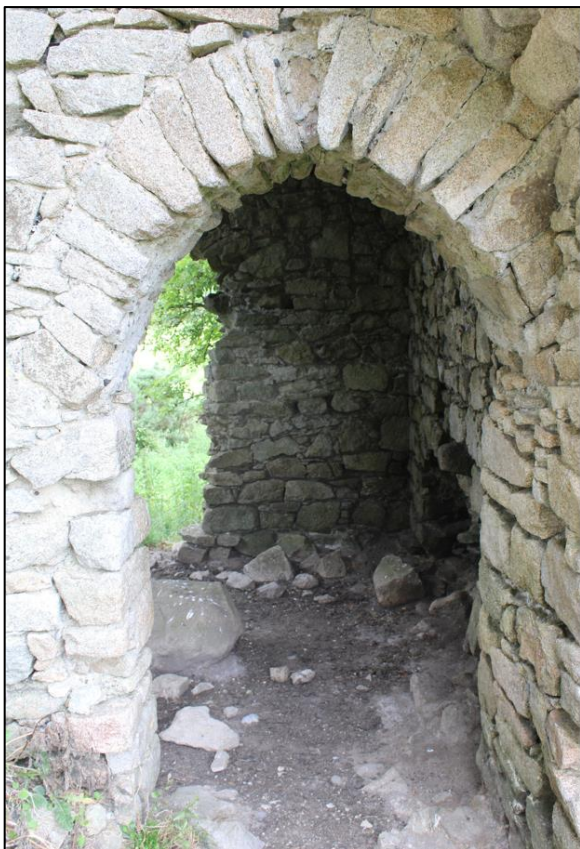
Excavation ceased at a possible floor level C4 which was visible on the western side of the tower and comprised large rectangular stones which were bound with mortar, C5 and which appeared to seal the stones to the wall. A possible void was noted at the northeastern corner of the tower and may indicate that there is a floor level below the one exposed. Clonmore Castle which is of a similar date to Arklow Castle has a similar floor surface with mortar bond (Plate 58).

Plate 58: Clonmore Castle note mortar and stone floor surface.

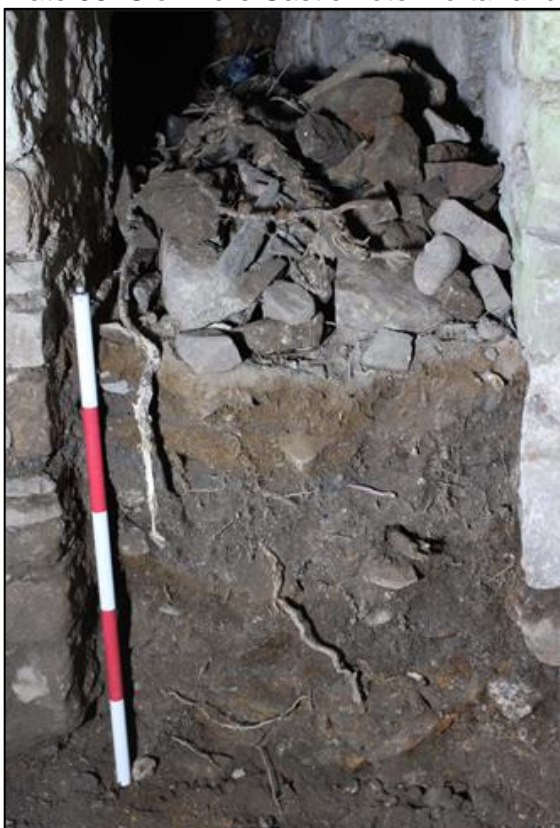
Plate 59: Entrance passage to the castle backfilled with 20th century debris material, C1, C2 and C3.

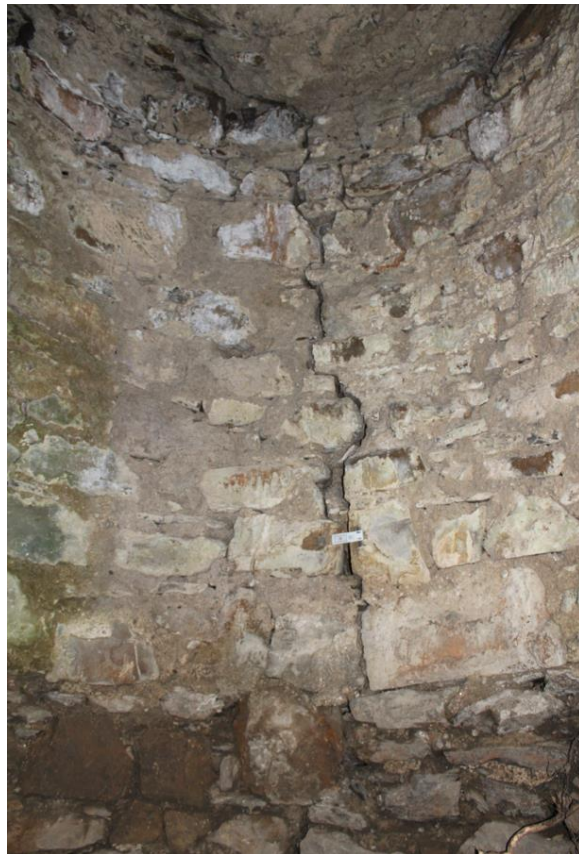
Plate 60: View of second crack in NW face of tower.

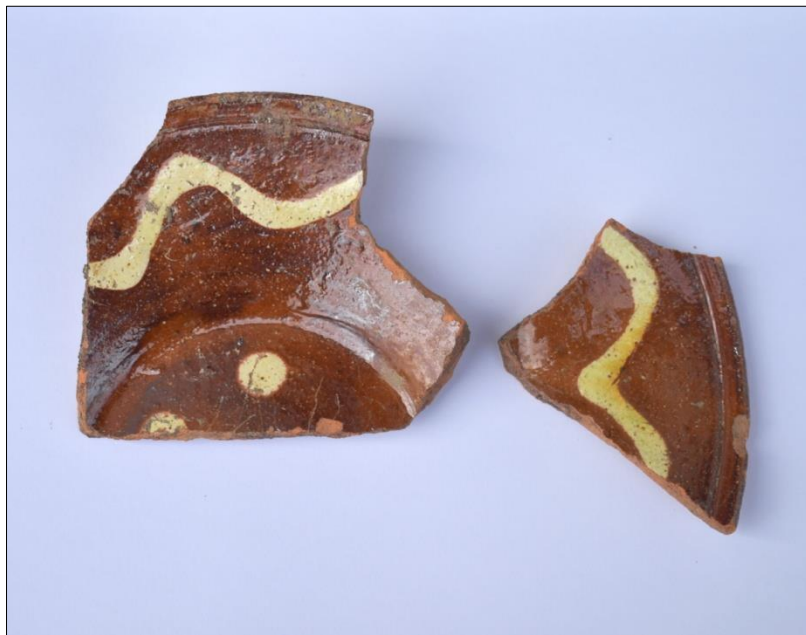
Figure 7 Trailed slip earthenware plate fragments (3:1 & 3.2)

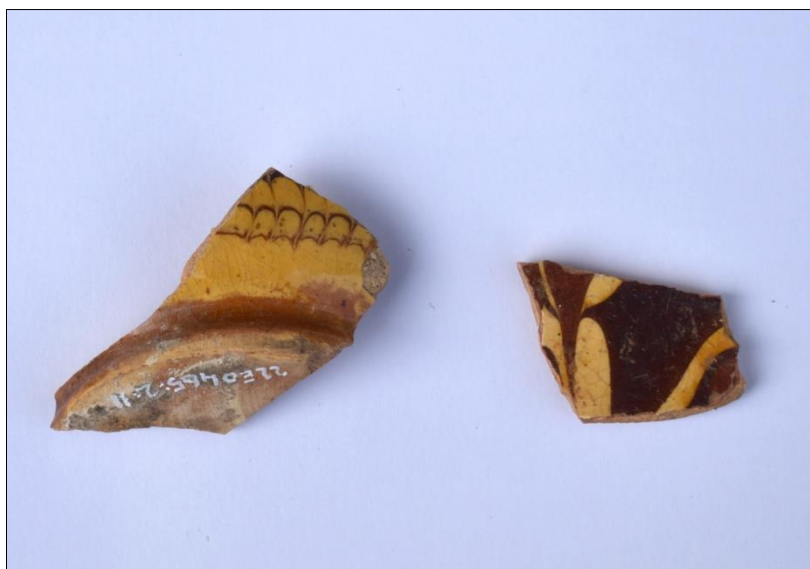
Figure 8 Staffordshire Bristol slipware sherds (2.11 & 2.10)

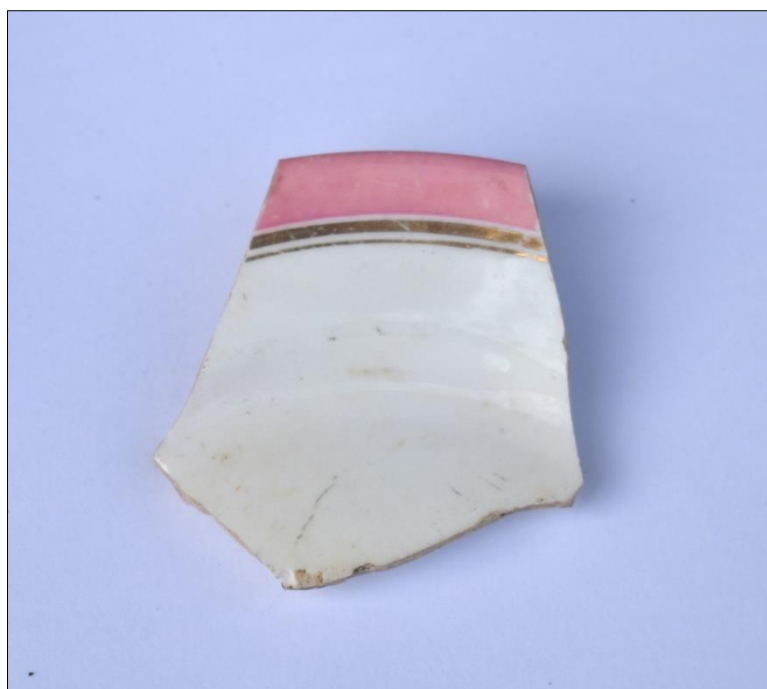
Figure 9 Lustreware sherd (2:13)

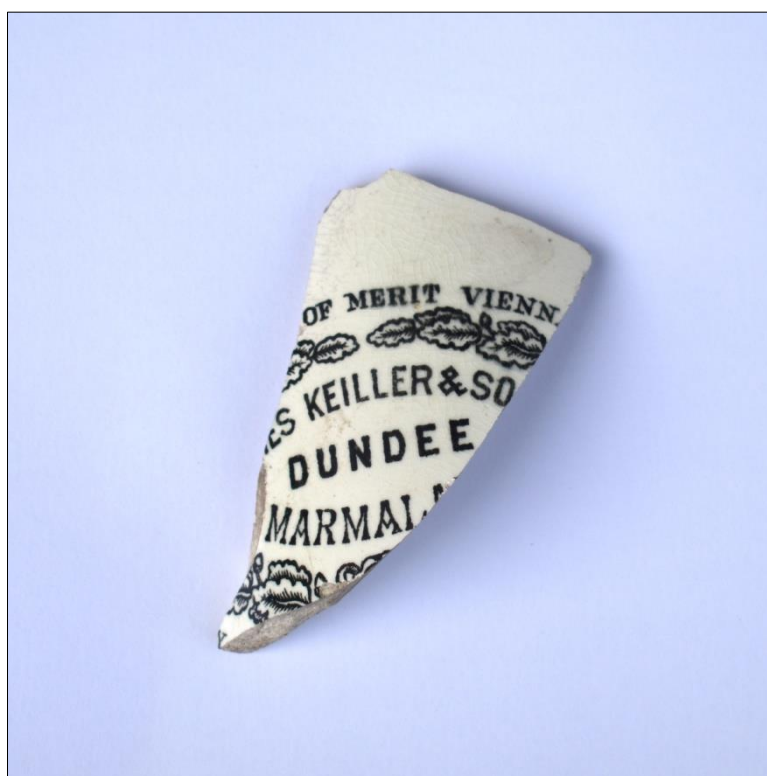
Figure 10 Dundee marmalade jar sherd (2:12)

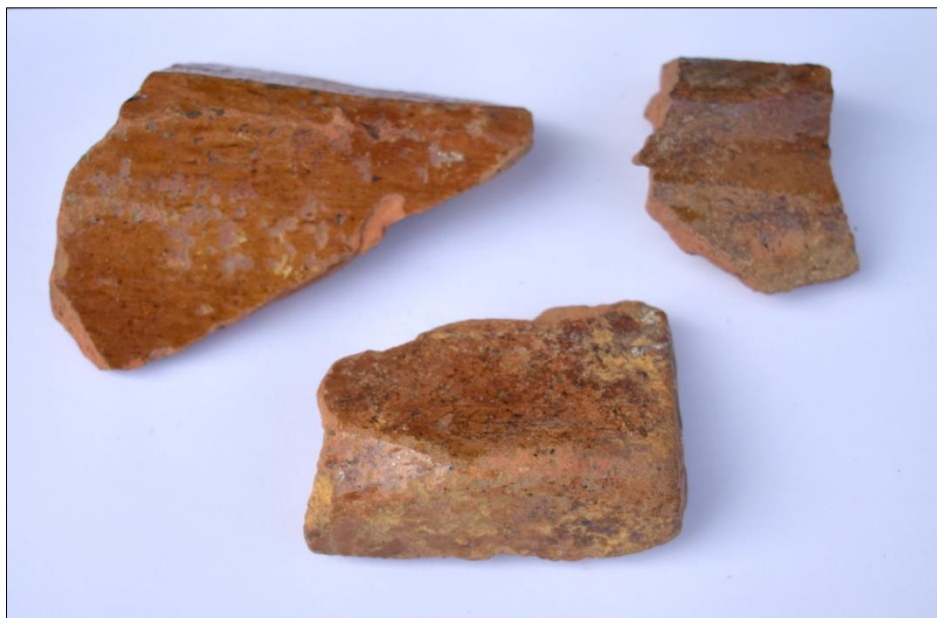
There are 6 post-medieval roof tiles in the ceramic assemblage from Arklow Castle. These include 4 ridge tiles and 2 plain roof tile fragments. The roof tiles were recovered from a backfill deposit (C3) inside one of the castle towers (Licence No. 22E0465; Director Yvonne Whitty).

Figure 11 Ridge tiles from Arklow castle

Ridge tiles began to appear in Ireland in the 13th century during the Anglo-Norman building campaigns (Wren, 2006, 180) and they continued to be used up until the 19th century. The tiles are typically U or V-shaped and were manufactured by casting and moulding clay over a wooden frame on a sanded board (ibid). The underside of the tiles is generally sanded because of this (ibid). A lead glaze, mostly a mottled green or brown colour was then applied.

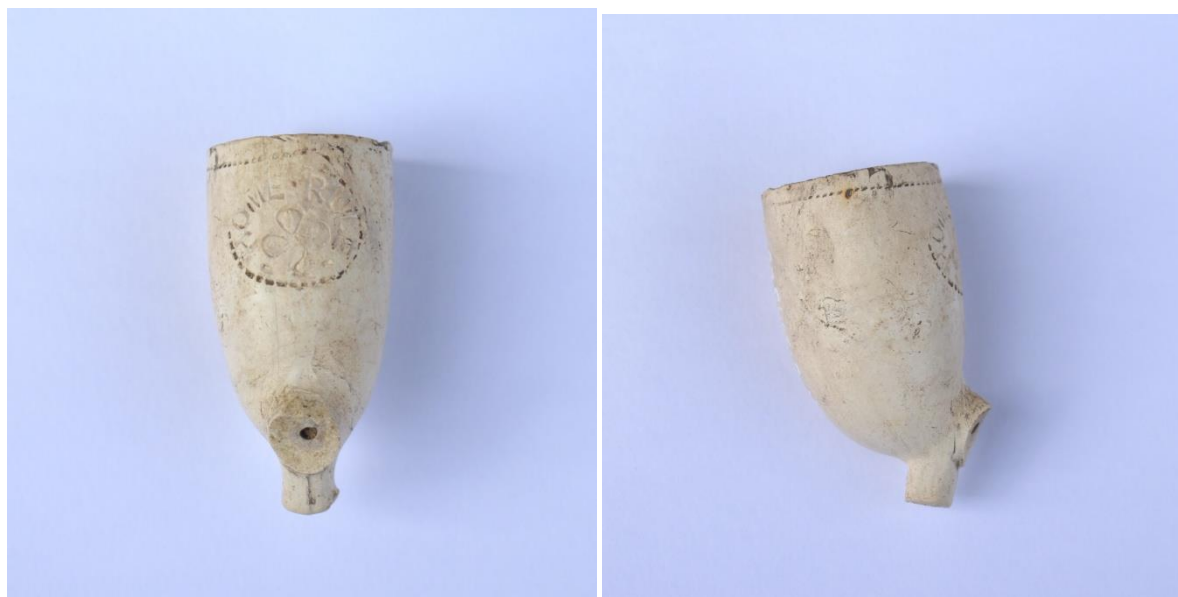
A single clay pipe bowl was identified at Arklow castle. It was recovered from a backfill deposit (C3) inside one of the castle's towers. The pipe bowl dates from the latter part of the 19th century and is stamped with the text '*Home Rule*' over a shamrock symbol. The Home Rule movement argued for Irish self-government and was particularly popular in the 1880's when Charles Stewart Parnell was the driving force behind the campaign. It was common practise during this period to add political slogans, often of Nationalistic slant, to clay pipes.

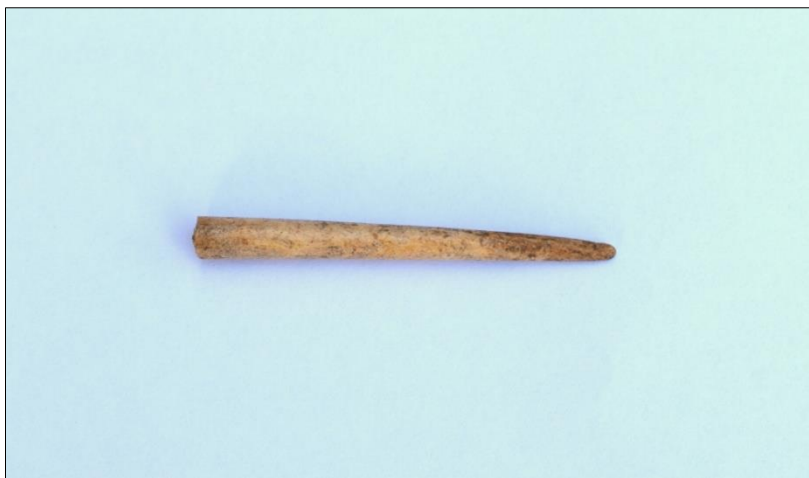
A single polished bone pin fragment was recovered during archaeological excavations at Arklow castle, Co. Wicklow. It came from a post-medieval deposit (C3) which was located inside the castle tower. The pin had been broken in antiquity and only the bottom, pointed end, survived (figure 1). The fragment measures 5cm in length and it has a finely polished surface. It most likely represents part of a garment pin used to fasten clothing. Parallels can be seen in Galway city, where an 18th century polished bone pin found during archaeological excavations, may have formed part of regimental regalia (Hurley 2004, 473). Arklow castle was used as barracks in the 18th and 19th centuries and its possible that the bone pin from this site had a similar function.

Figure 12 Polished bone pin fragment

Catalogue: 22E0465:3:5, polished bone pin fragment, circular cross-section , pointed tip, length: 50mm, thickness: 5mm
