# Wicklow Bridges Project

Assessment of the risk of barriers to  
migration of fish species in County Wicklow  
Report to Wicklow Heritage Forum

**Inland Fisheries Ireland  
November 2012**

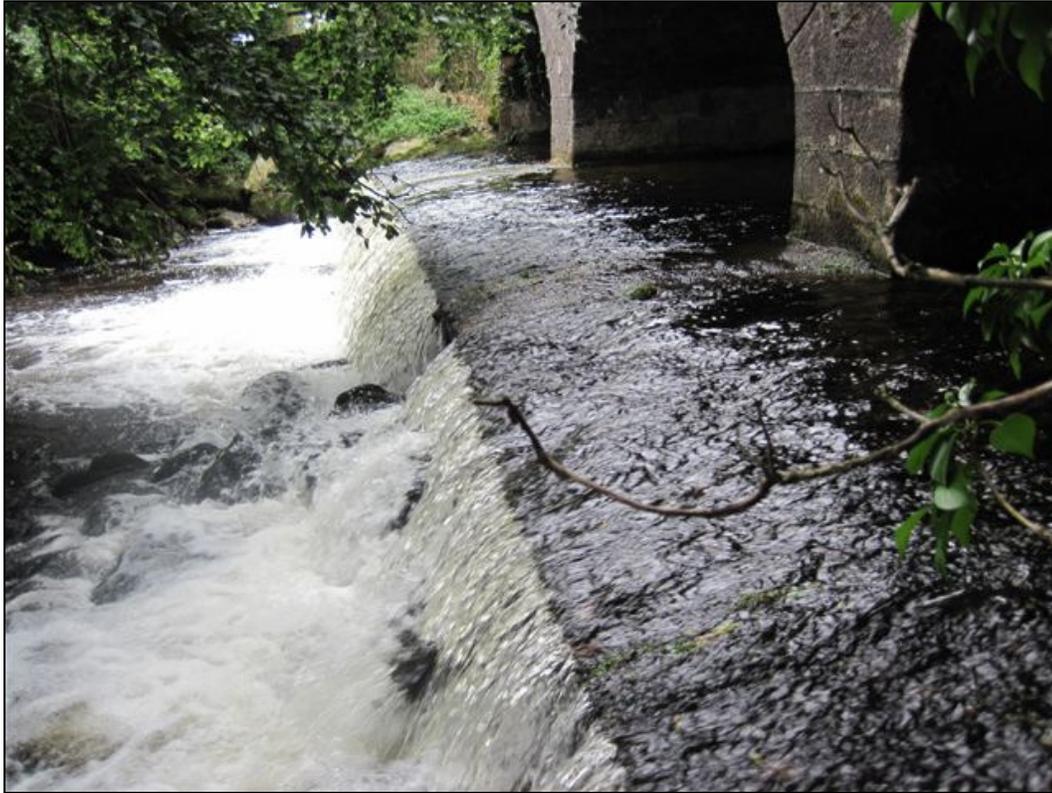
Figure 9. Ballinglen Bridge: This photo demonstrates the fish passage issues associated with laminar flow, flow velocity and the perching associated with this scour protection apron.

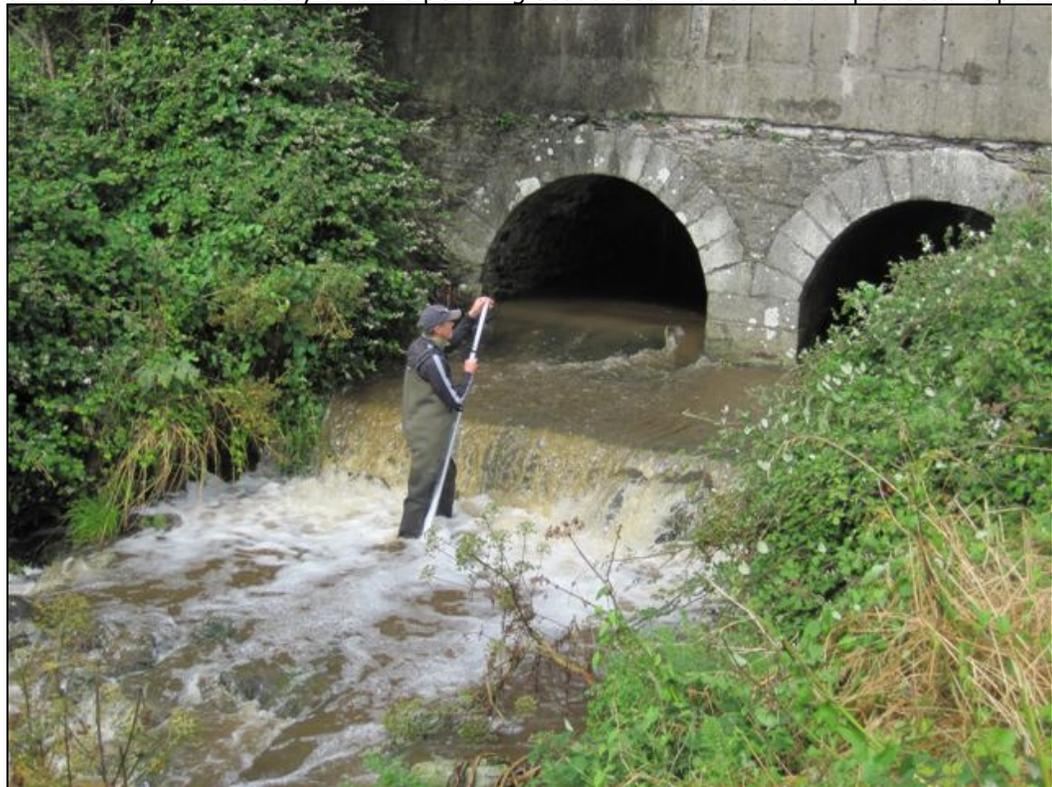
Figure 10. Threemilewater N11: photo demonstrates the combination of high velocities on a moderately sloped apron, laminar flow and perching, creating an impassable barrier to fish. This site would benefit from a mammal pass on this very busy/fast stretch of road

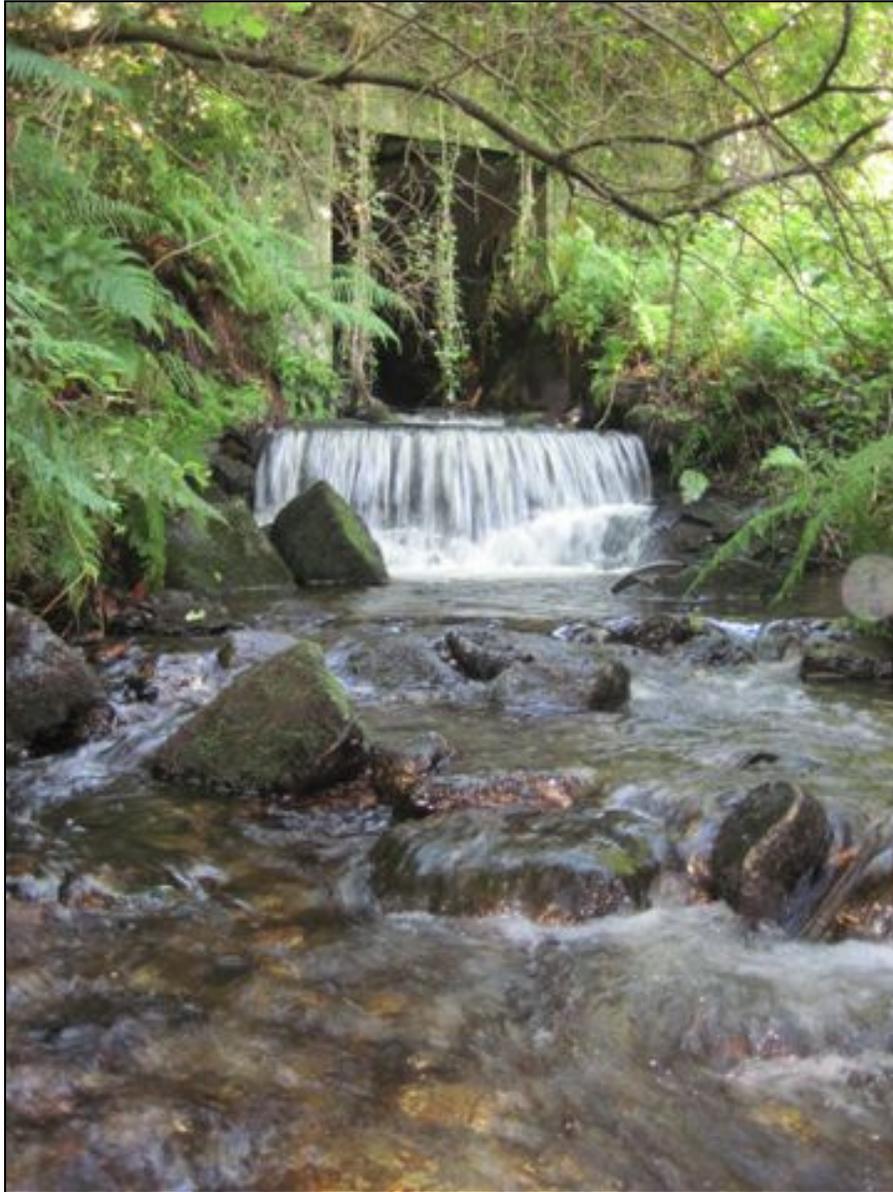
Figure 11. Photo showing a perched concrete scour protection apron on a tributary of the Avonmore River. The watercourse at this location represents excellent salmon nursery habitat. The main Annamoe to Laragh road is located immediately downstream of this site and the Armco Style culvert used for that crossing also represents an impassable barrier to fish passage.

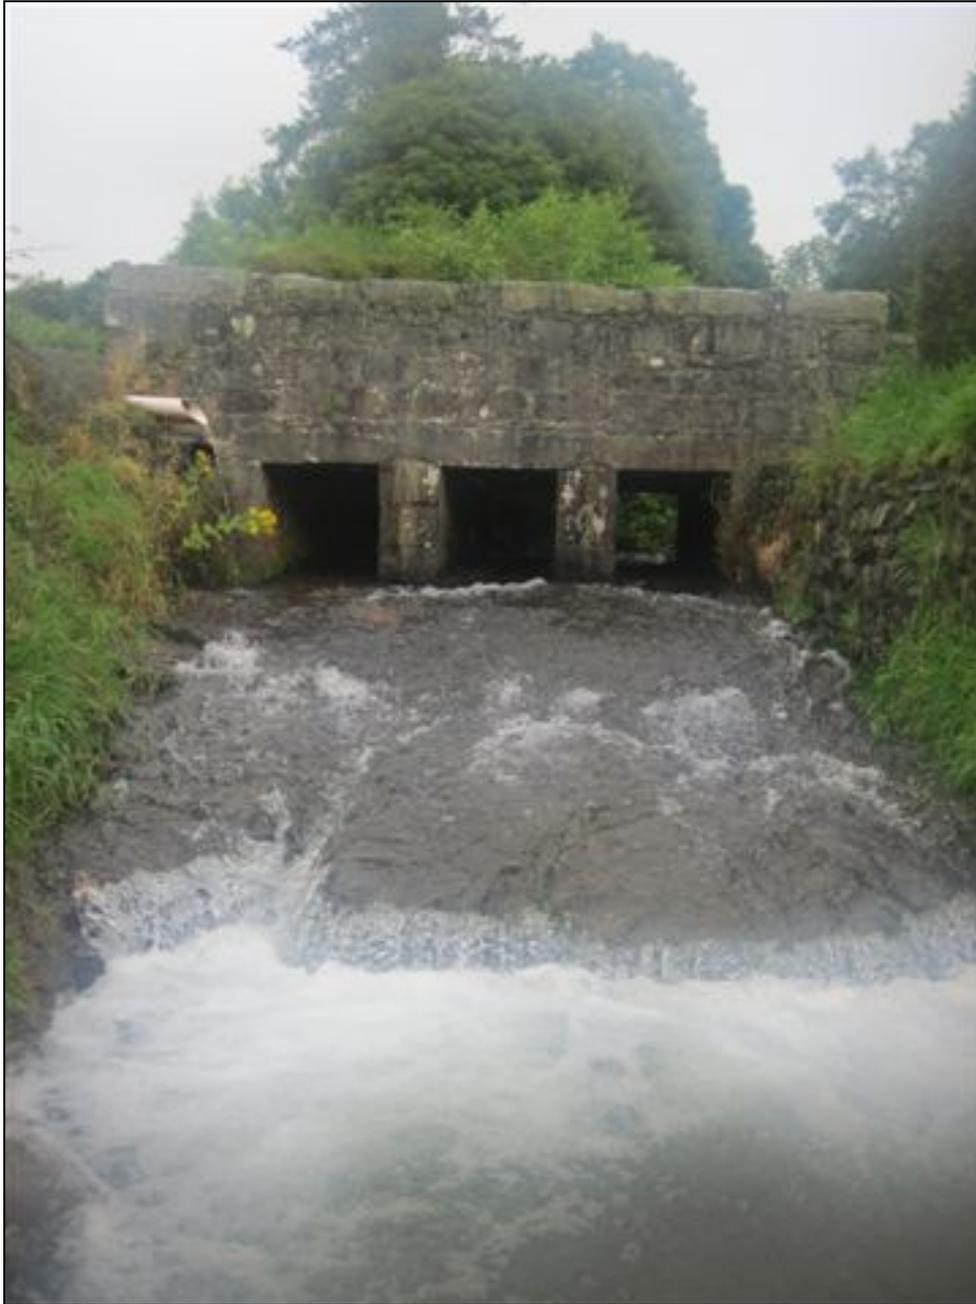
Figure 12. Old masonry bridge structure near Avoca: composed of three masonry 'box' culverts with a long and moderately sloped concrete scour protection apron downstream. This photo shows the high velocities and laminar flow associated with this structure.

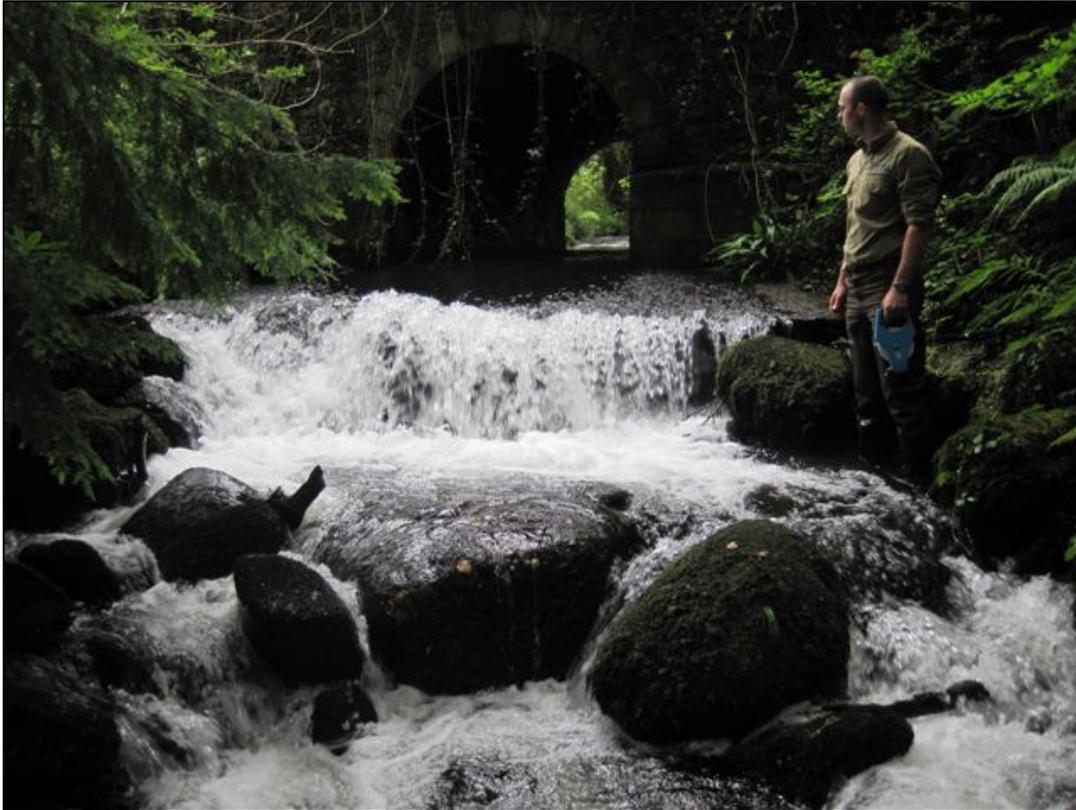
Figure 13. Photo of Ballyhad Bridge apron (Avonmore system: showing the perching, laminar flow and high velocities associated with this structure). Excellent salmon nursery habitat upstream. Site would also benefit from a mammal pass on this very busy/fast stretch of road.

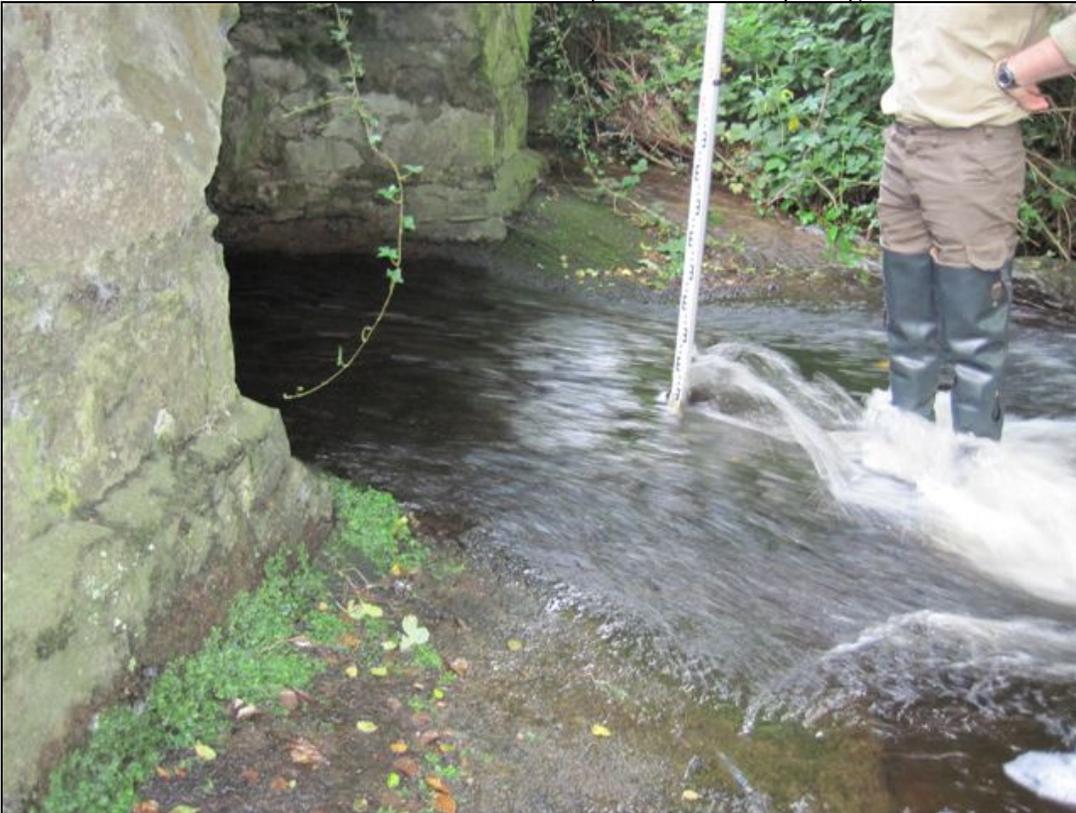
Figure 14. Leabeg Stream at Leabeg Bridge: please note flow velocity and laminar flow associated with this moderately sloped concrete scour protection apron.

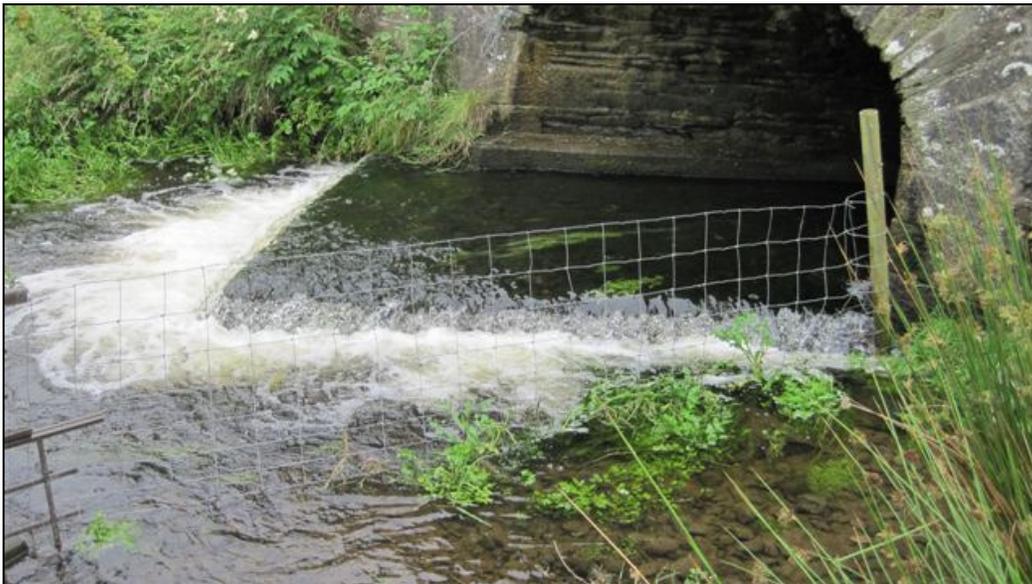
Figure 15. Mullyclagh Bridge: site in headwaters of the Slaney catchment before the installation of a series of low level weirs downstream of the perched scour protection apron. Electro-fishing of this site found excellent populations of trout, and salmon parr, downstream of this apron.

An effective approach to deepening the water and slowing the flow is to raise the tailwater level by installing a weir downstream of the scour apron. This will result in backing up the water level over the length of the apron. This approach can also ameliorate any perching problems such as found at Mullyclagh Bridge (on the upper reaches of the Carrigower in the Slaney catchment). Figures 15 and 16 illustrate the retrofitting of a number of low level weirs downstream, which was implemented as part of a road and bridge realignment project undertaken by the NRA and Wicklow County Council in late 2012. Figure 17 demonstrates the generic design of a 'low level weir' solution (Anon, 2000). The weirs downstream of Mullyclagh Bridge (shown in Fig. 16) were constructed using rock. The use of rock is more aesthetically pleasing and more closely mimics natural conditions, but a variety of other materials could be used such as concrete, wood and metal.

- We believe that the works recently undertaken at Mullyclagh Bridge, (Figures 15-17) demonstrate a relatively simple solution to fish passage issues at most existing scour protection aprons. We understand that the cost of the works undertaken at the Mullyclagh Bridge site were in the region of €5000. We would be hopeful that many of the fish passage issues highlighted at smaller bridge and culvert sites could be rectified with similar solutions when routine bridge repairs/maintenance operations are being carried out by relevant authorities (Wicklow County Council or the National Roads Authority).

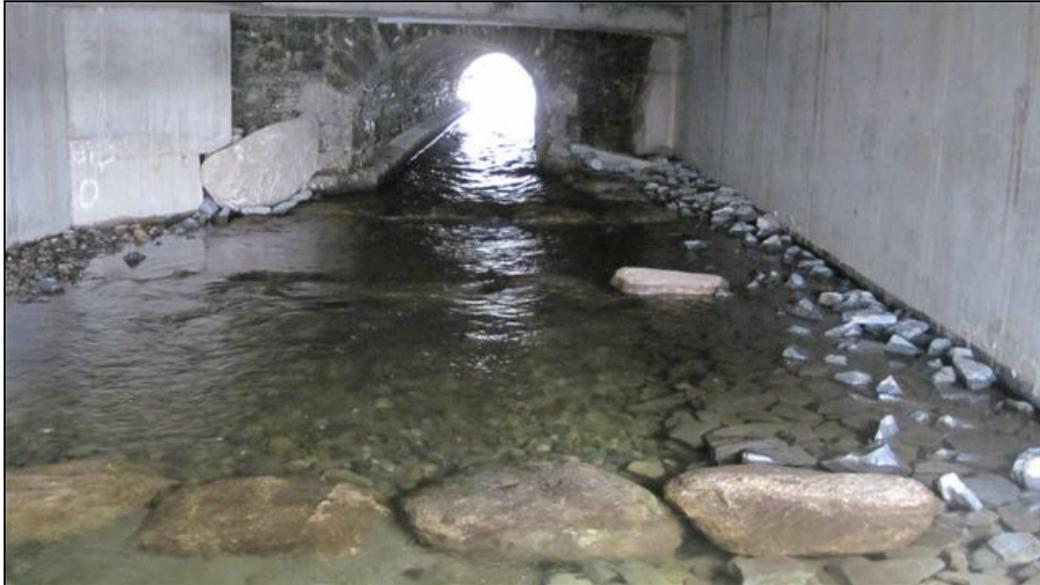
Figure 16. Mullyclagh Bridge after road/bridge widening and incorporation of low level weirs.

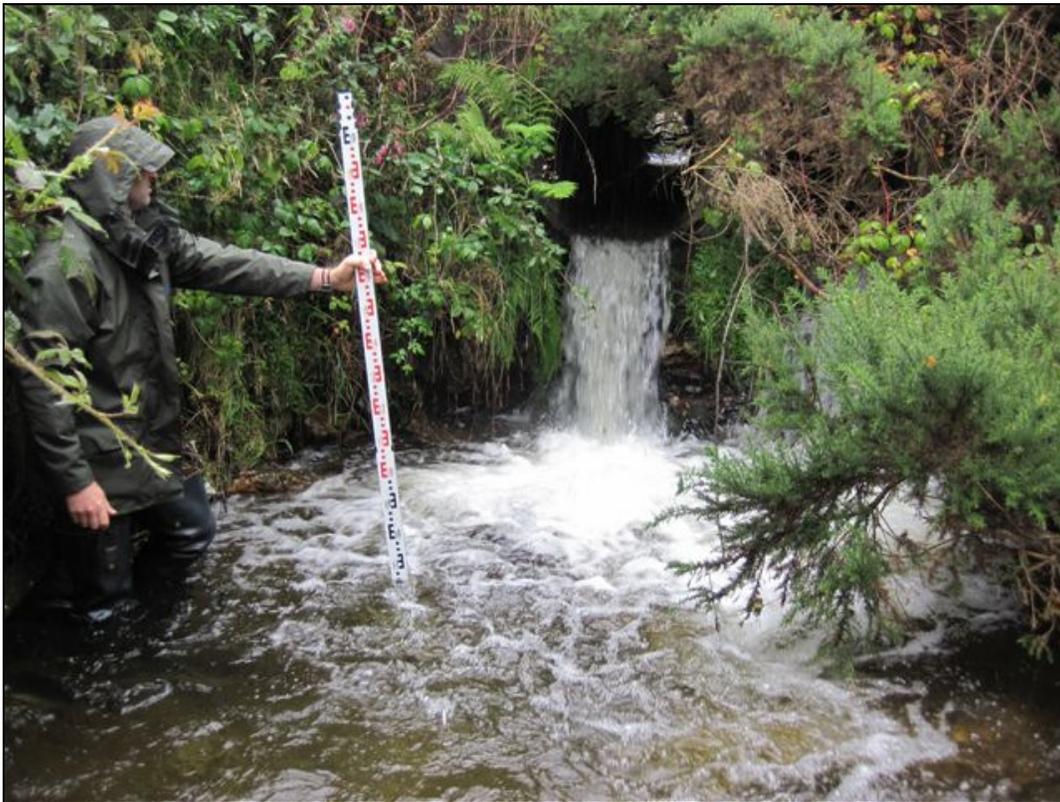
Figure 18. Perched pipe culvert at Greens Bridge, headwaters of the Ballycreen/Macreddin Brook. Significant fall/jump downstream of pipe. Bank erosion noted downstream also.

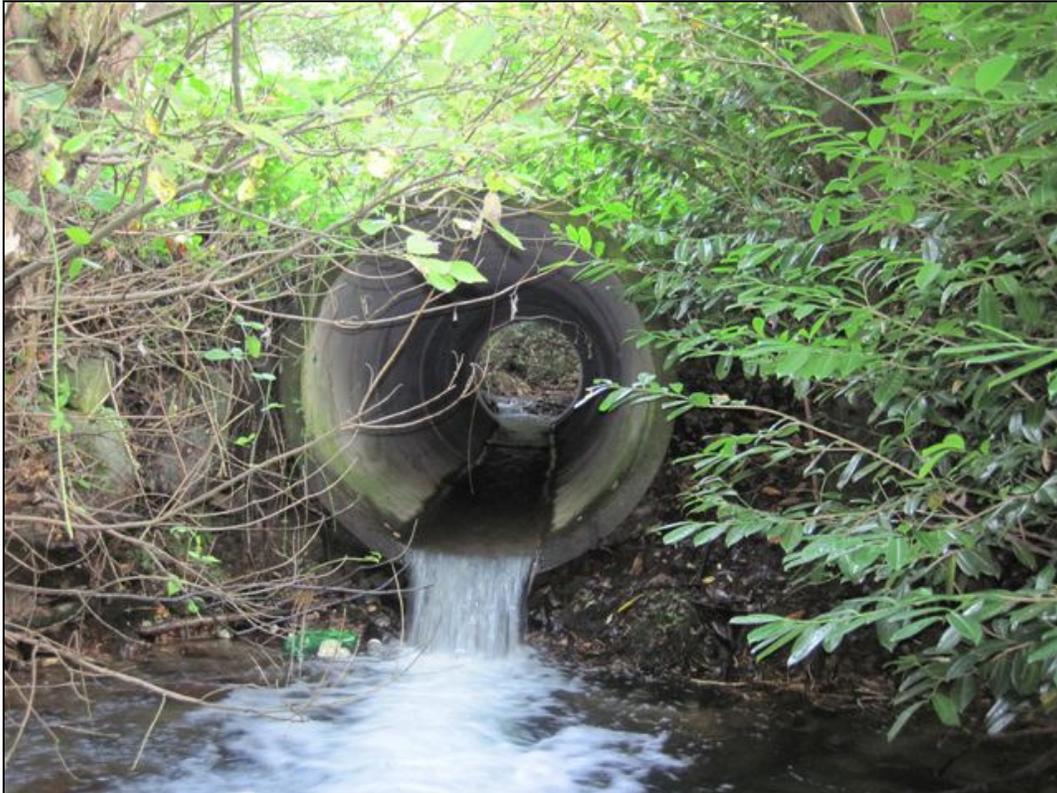
Figure 19. Large perched concrete pipe culvert crossing of Avoca trib. on private road near Avoca. Sea trout noted in pool downstream of culvert. Fish passage difficulties at this site could have been avoided had this culvert been lain below bed level and backwatered.

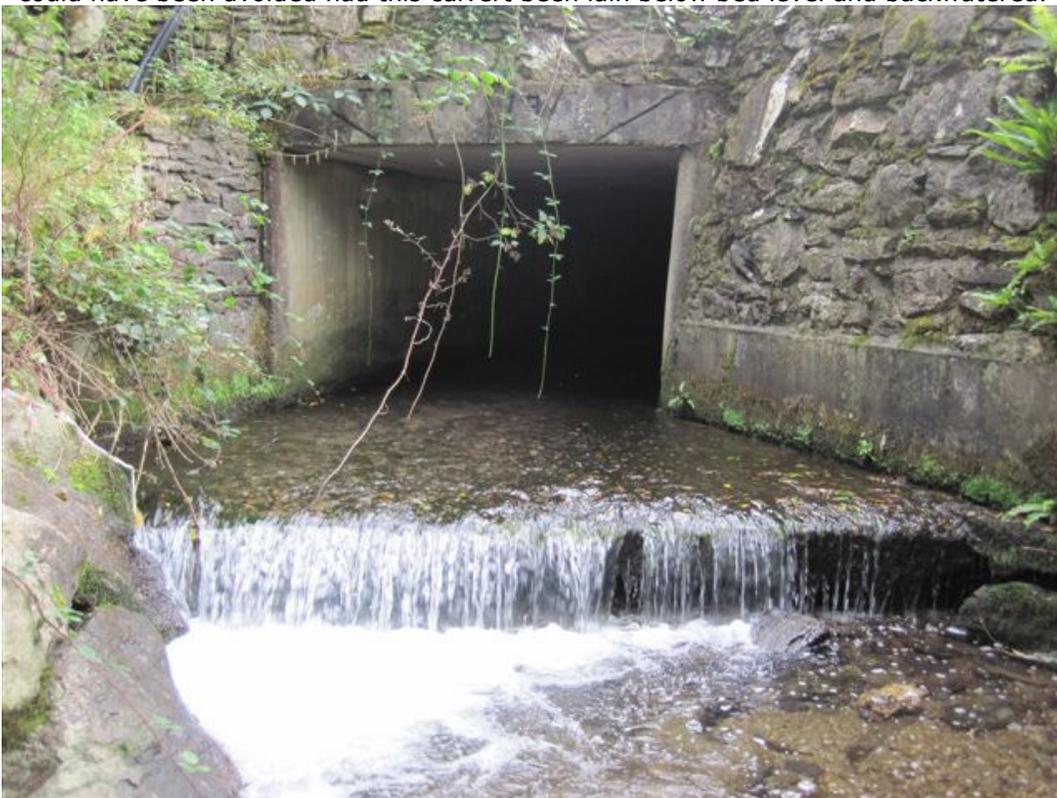
Figure 20. Box culvert with perched concrete scour protection apron. Private roadway on a Goldmine River trib. Structure represents significant impediment to fish passage.

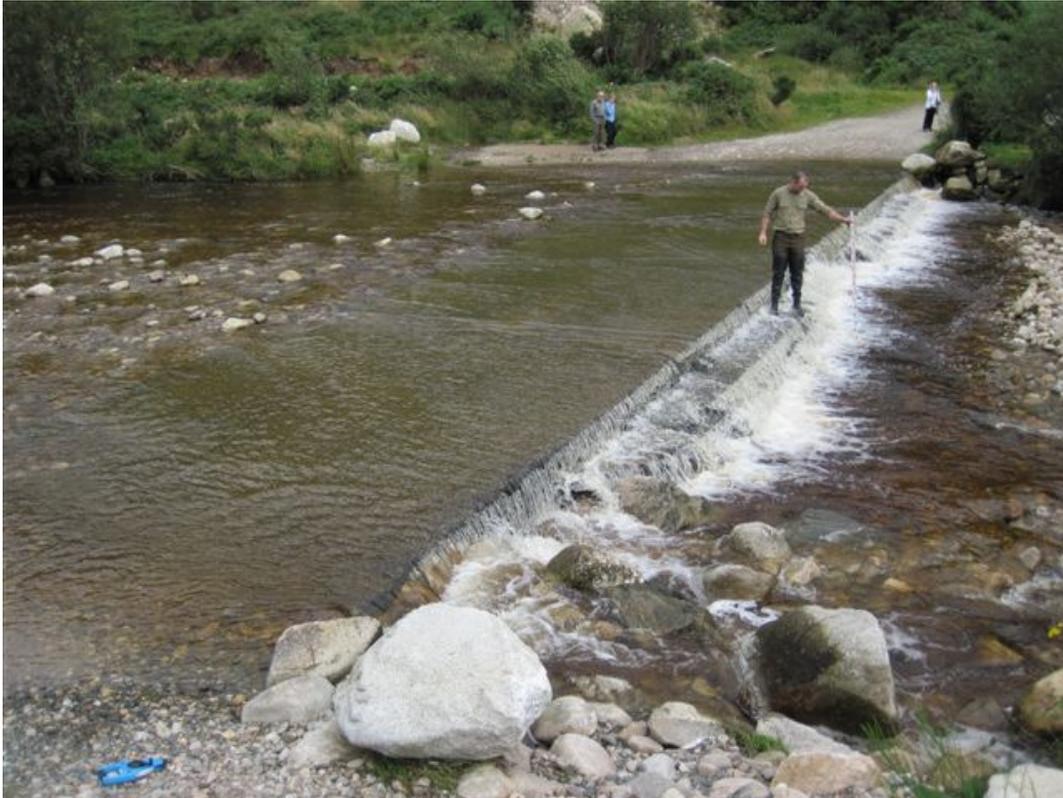
Figure 21. Ford on Avonbeg Main Channel at Glenmalure. Structure is composed of a series of undersized concrete pipes lain parallel to each other and encased in concrete. The downstream movement of river bed material has blocked these pipes and the structure now acts as a dam.

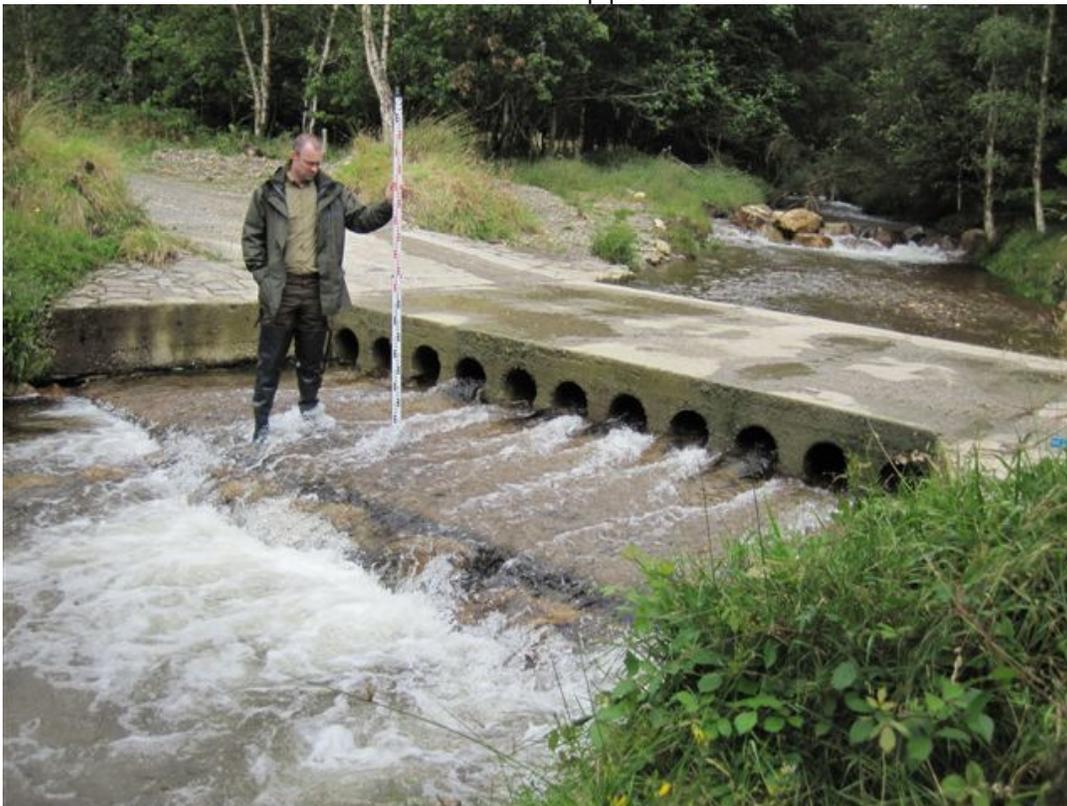
Figure 22. Ford structure on Avonbeg tributary, utilising undersized pipes encased in concrete, with scour apron downstream. Many of the culvert pipes were fully or partially blocked. Structure represents a significant impediment to the free passage of fish.

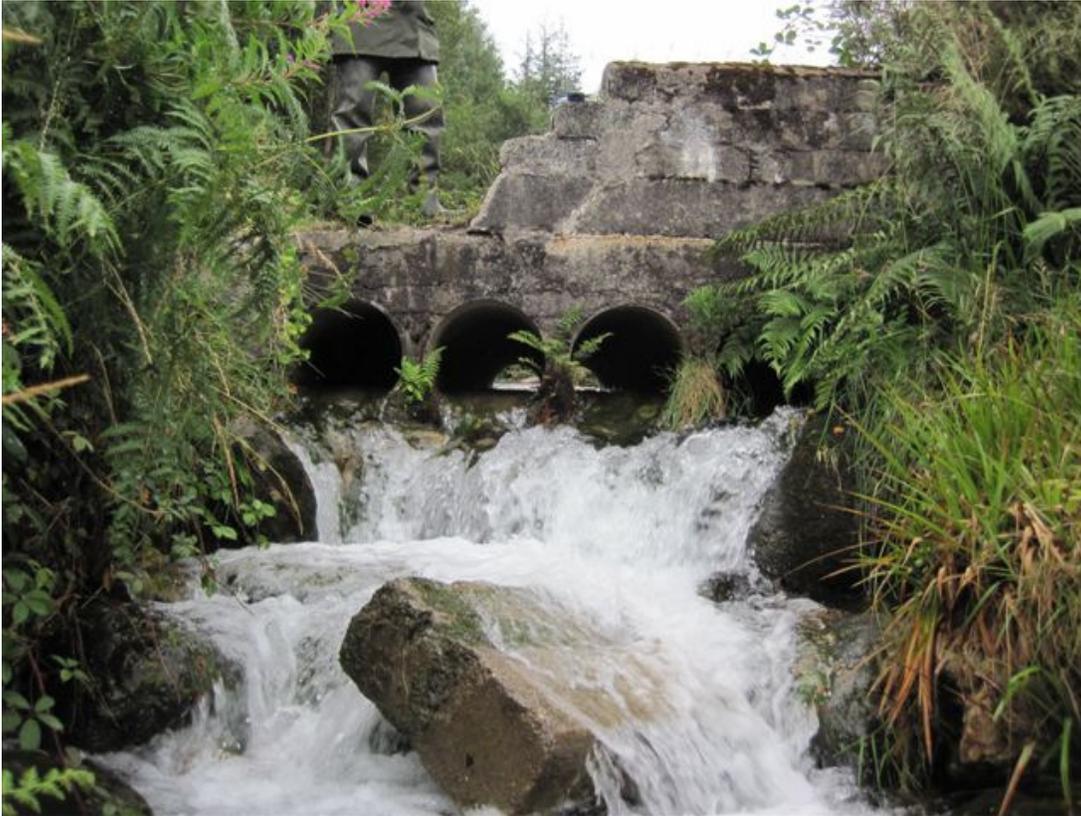
Figure 23. Perched pipe culvert crossing with scour protection apron over Mucklagh Brook, Ow river tributary. Structure represents barrier to the free passage of fish.

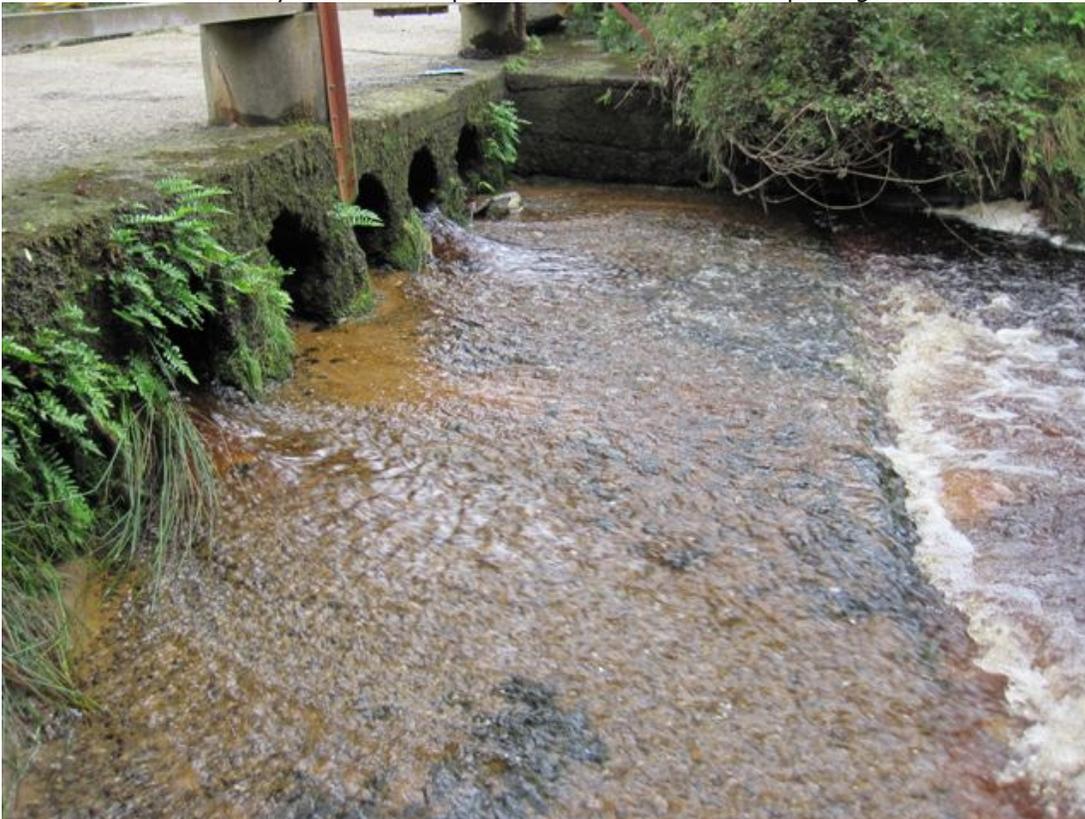
Figure 24. Ford Structure on Avonbeg trib. utilising undersized pipes encased in concrete, with scour apron. Majority of the culvert pipes fully or partially blocked. Structure represents a barrier to the fish passage, with excellent salmon spawning/nursery habitat u/s and d/s. Pipe size too small to facilitate most fish passage.

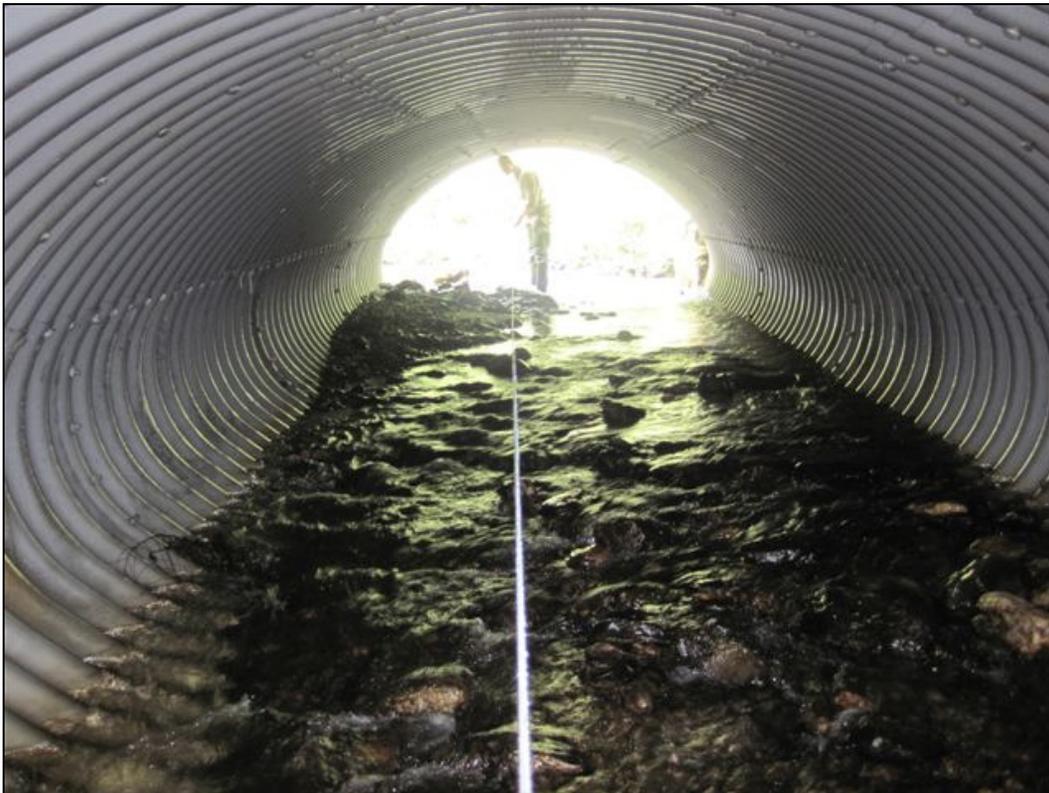
Figure 25. Furnace Bridge, Armco style culvert, which replaced an old masonry bridge, structure constructed well below bed level, backwatered throughout, natural bed material deposition within structure, fish habitat over length of structure maintained. Free passage of fish guaranteed. This site would also benefit from a mammal pass on this very busy/fast stretch of road.

Figure 25 shows Furnace Bridge (crossing a tributary of the Avonmore River), where an old masonry structure was replaced with a corrugated steel (Armco style) culvert. This structure was laid well below the upstream invert of the stream and therefore is backwatered over its entire length. The Furnace Bridge site has developed a natural gravel river bed throughout, which provides habitat for fish and facilitates their free passage at all times. A box culvert on the Griffeen River (Liffey trib.) in County Dublin is shown in Fig. 26. This culvert was also laid well below (>500mm) the upstream invert of the stream and ensures fish habitat throughout the structure and the free passage of all fish at all times. The Griffeen box culvert also includes a mammal pass (something that would be difficult to incorporate/retrofit into the Furnace Bridge culvert because of its shape).

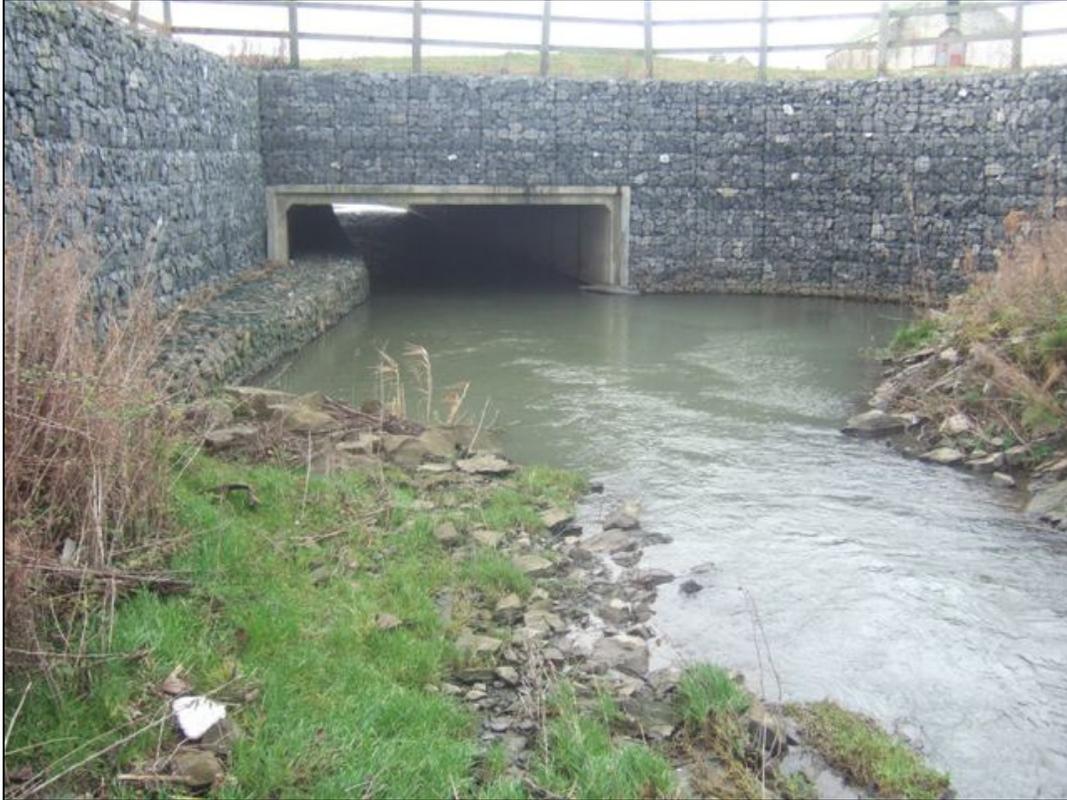
Figure 26. Griffen River, Liffey trib. Co. Dublin. Backwatered box culvert. Culvert bed 500mm below river bed level. Natural bed material deposition within structure, fish habitat and passage over length of structure maintained. Structure includes a mammal pass, the incorporation of which would have been very difficult within a round/elliptical culvert

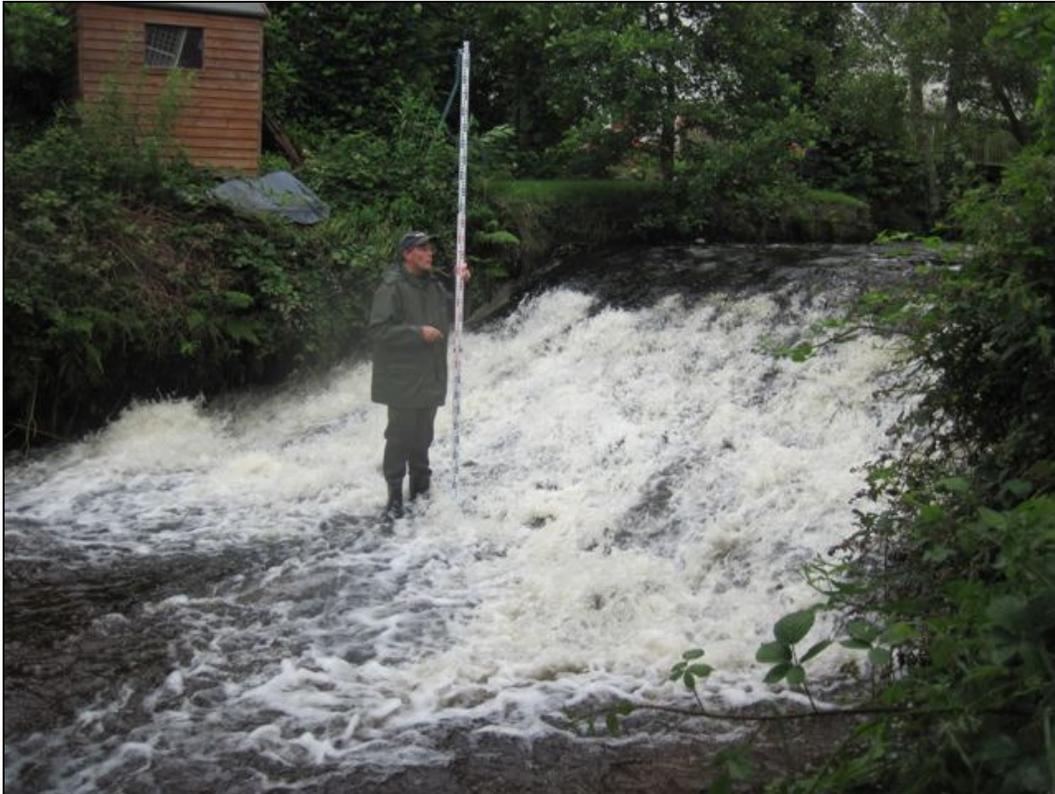
Figure 27. Dam across the Macreddin/Ballycreen Brook in Aughrim. This structure represents an impassable barrier to fish passage. Excellent salmon spawning/nursery habitat upstream of this site. Catchment wide electrofishing survey of the Avoca system in 2002 highlighted the absence of juvenile salmon on the Macreddin/Ballycreen Brook upstream of this structure.

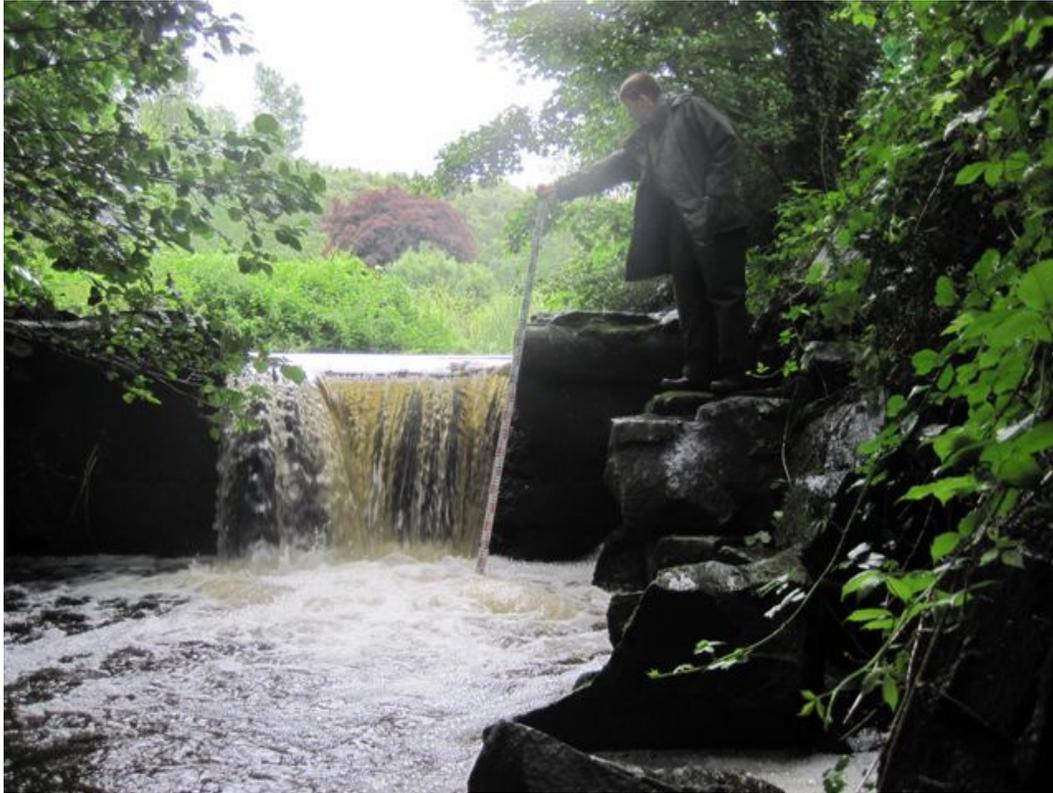
Figure 28. Dam across the Ballyduff Stream a close to Arklow. Original purpose of this dam believed to be the creation of a fish pond. Structure represents an impassable barrier to all fish passage, with excellent salmon spawning/nursery habitat upstream.

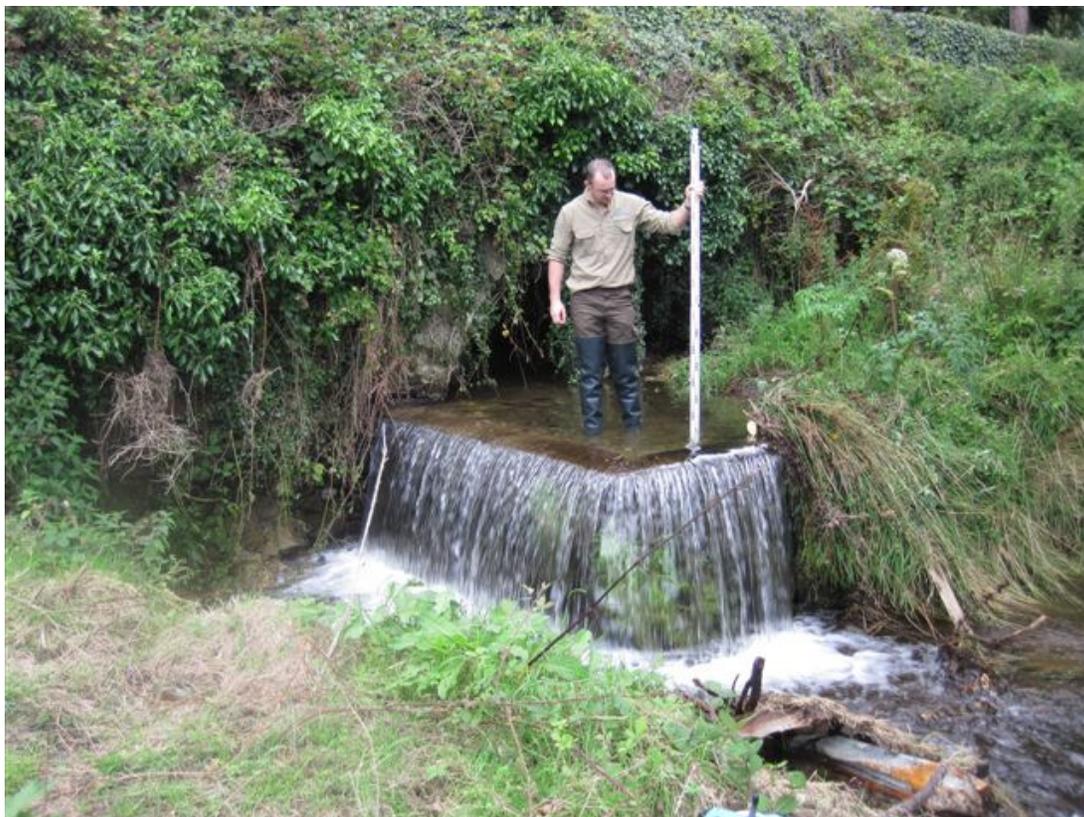
Figure 29. Structure at Preban Bridge (Derry Water system) near Ballinglen purpose of which we were informed was to provide for a gravity feed water supply to nearby farm
