Avifauna of bridges in Co. Wicklow

Executive Summary 2012

**Dr. Alex. Copland
Senior Conservation Officer
BirdWatch Ireland**

For Wicklow County Council

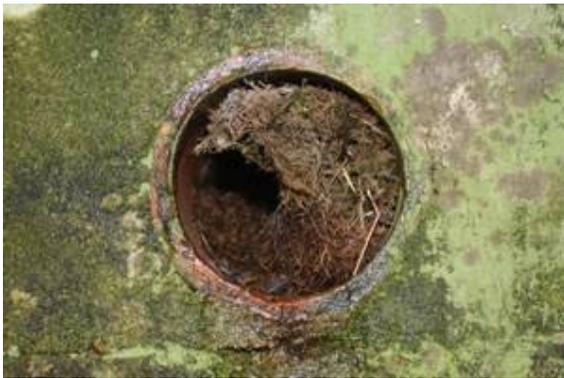
Fig 1.1 Dipper nest in bridge cavity (pipe)
230 Old Bridge (Lough Dan),
Upper Avonmore

The actual construction of a Dipper nest varies depending upon where it is located. If there are small holes in the bridge, with little room for additional nest material, then a small nest cup may be all that is present. However, where the nest is built on a flat platform, the structure can be considerable. Common nest locations include cavities in the bridge structure (Figure 1.1), on ledges or pipes (Figure 1.2), on stones jutting out from the bridge (Figure 1.3) or in Ivy (Figure 1.4).

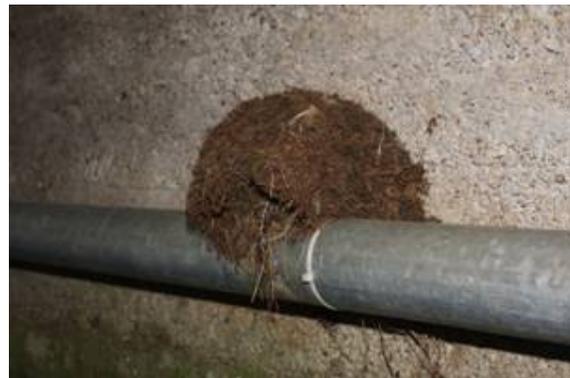
Fig 1.2 Dipper nest on pipe
324 Sheeanabeg Bridge, Ballycreen

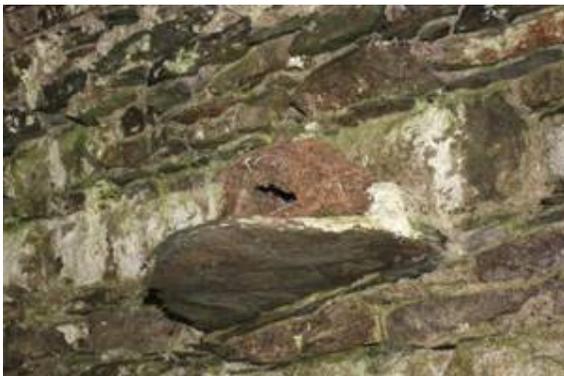
Fig 1.3 Dipper nest on protruding stone
222 Meetings Bridge, Avonbeg

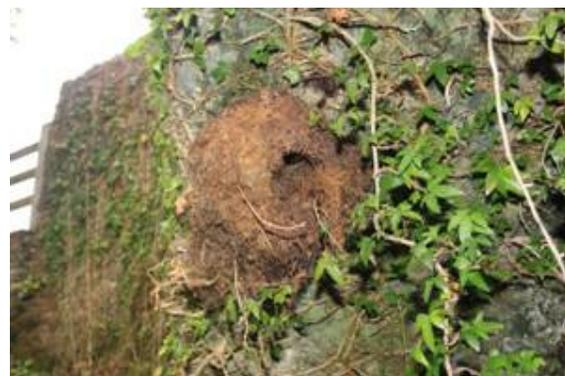
Fig 1.4 Dipper nest in Ivy
299 Ballinglen Bridge, Moyne

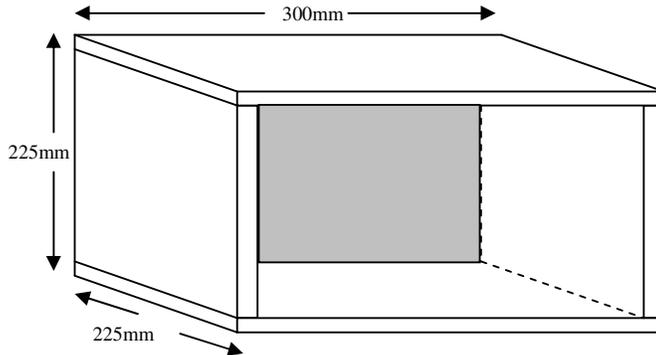
This open-fronted nestbox (Fig 1) can be used where there is no cover above the proposed site (e.g. on the outside of a bridge parapet or where the bridge deck may be open). For ease of fitting, a back can be added to the box, made from a sheet of plywood or hardboard, or small metal brackets can be positioned as appropriate. A lip, no more than 50mm (2") high, can be added to the front of the box.

Figure 1: Dipper nesting box

Two designs for providing nesting sites for Dipper are illustrated below. Both designs can be made from exterior grade (marine) plywood or from timber planks 225mm (9") wide and 25mm (1") thick (if timber is used, it should be treated with a non-toxic wood preservative (such as *Sadolin*)).

Artificial nest sites should be located above running water, and high enough above the water so that there is no risk of it getting washed away by high river levels. Such sites will often be used during winter by roosting birds, so winter water level should also be a consideration. They should also be positioned away from ledges where predators, such as Otter, Mink or Rat cannot get access to the nest.

Both designs require sturdy fixings to the structure of the bridge. In all cases, positioning should be carefully considered so as not to damage the bridge structure. Holes in brackets or back-boards should be lined up with appropriate fixing points on the bridge (such as gaps in stonework with solid, stable mortar) and fixed in place using screws with masonry plugs before attaching them to the box/platform.

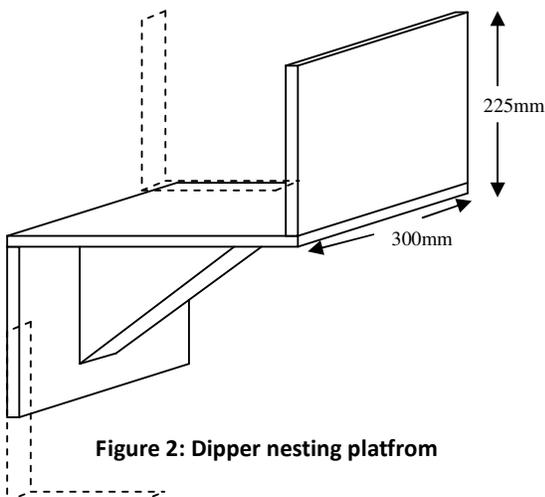
The platform (Fig 2) is designed for use under bridges where it will be sheltered from the weather. Its shape allows it to be fitted to vertical pillars or abutments, the underside of horizontal spans, or anywhere along the curves of an arch (Fig 3). The boards should all be the same shape and size. Depending upon the location, fixing can either be with a timber backboard (as illustrated) or with metal brackets (also illustrated – dotted lines). Similarly, the addition of brackets may be needed to support the boards depending upon position of fixing.

Figure 2: Dipper nesting platform
